**CAPA**

# Quality**Watch**

A Periodic Report on Non-CAPA Certified  
Aftermarket Replacement Parts

## **Report Number 3**

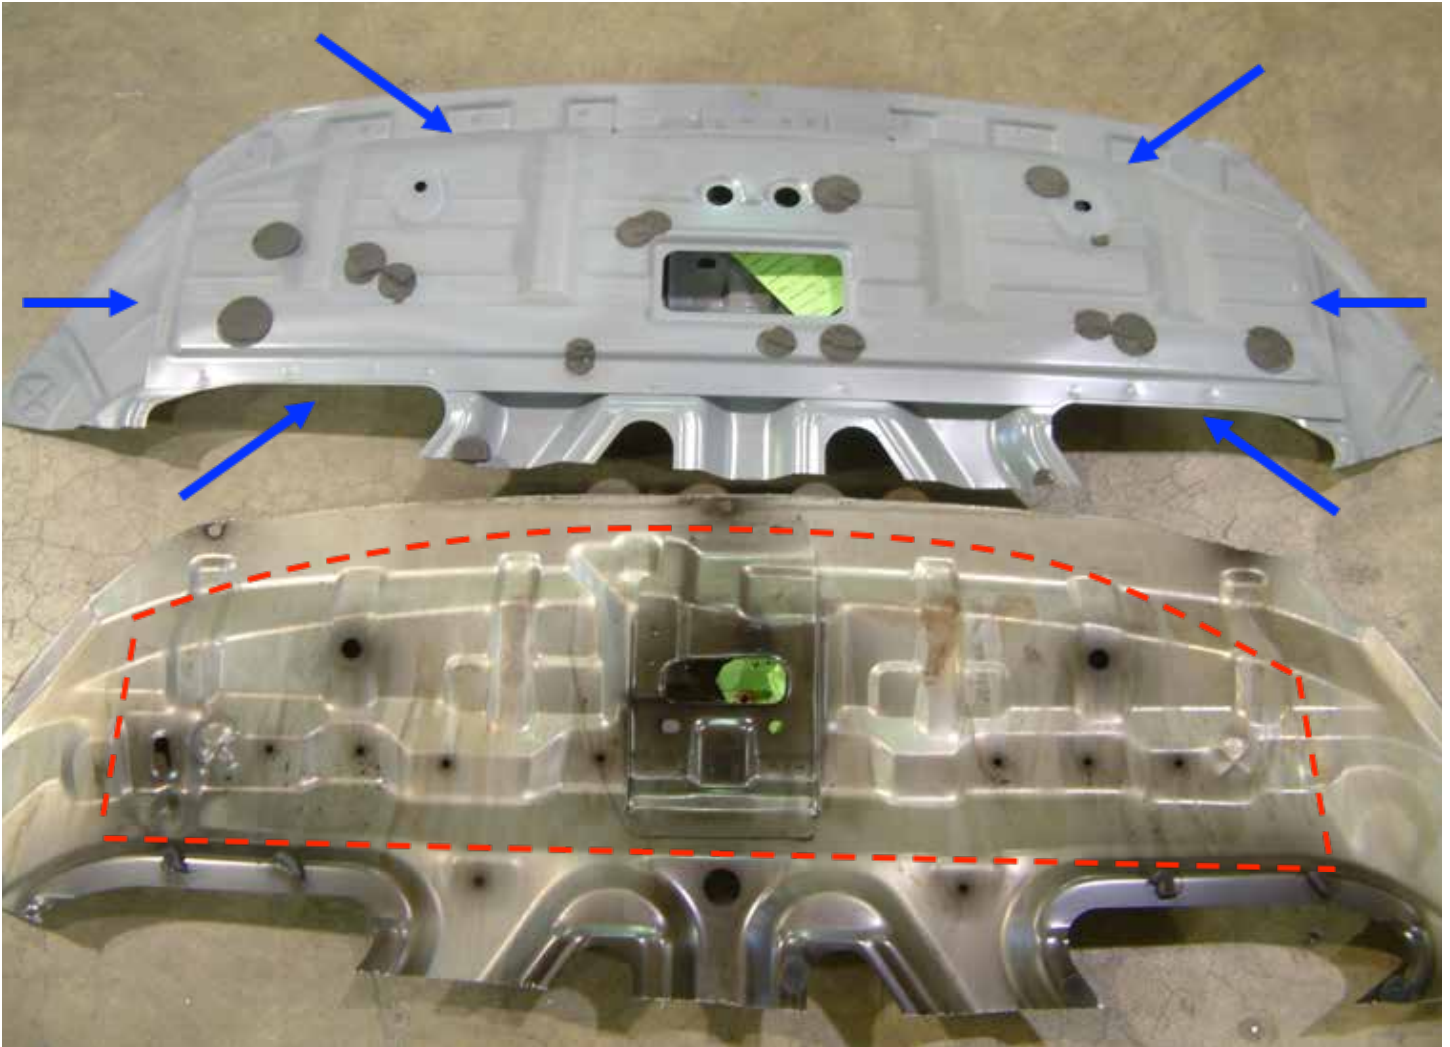
**Figure 1: Missing Striker Reinforcement Plate**

Two of the car company brand hoods were designed using a reinforcement plate. This plate is located in the front of the hood between the striker and the outer skin. The non-CAPA Certified aftermarket parts were completely missing this critical reinforcement plate.

The reinforcement plate provides structure and support to the outer skin in the striker area. Because the reinforcement plate is located between the inner and outer skins of the hood, its presence or absence cannot be seen by simply looking at the hood. For an aftermarket part to meet CAPA requirements, all construction features of the car company service part must be present and tested for comparability to the car company brand part.

These are portions of the inner skins of a car company brand (upper) and non-CAPA Certified aftermarket (lower) hood for the Kia Rio Sedan 03-05. The blue arrows indicate the perimeter of the striker reinforcement plate on the car company brand part. The non-CAPA Certified aftermarket part is missing the reinforcement plate entirely, as indicated by the red dotted line.

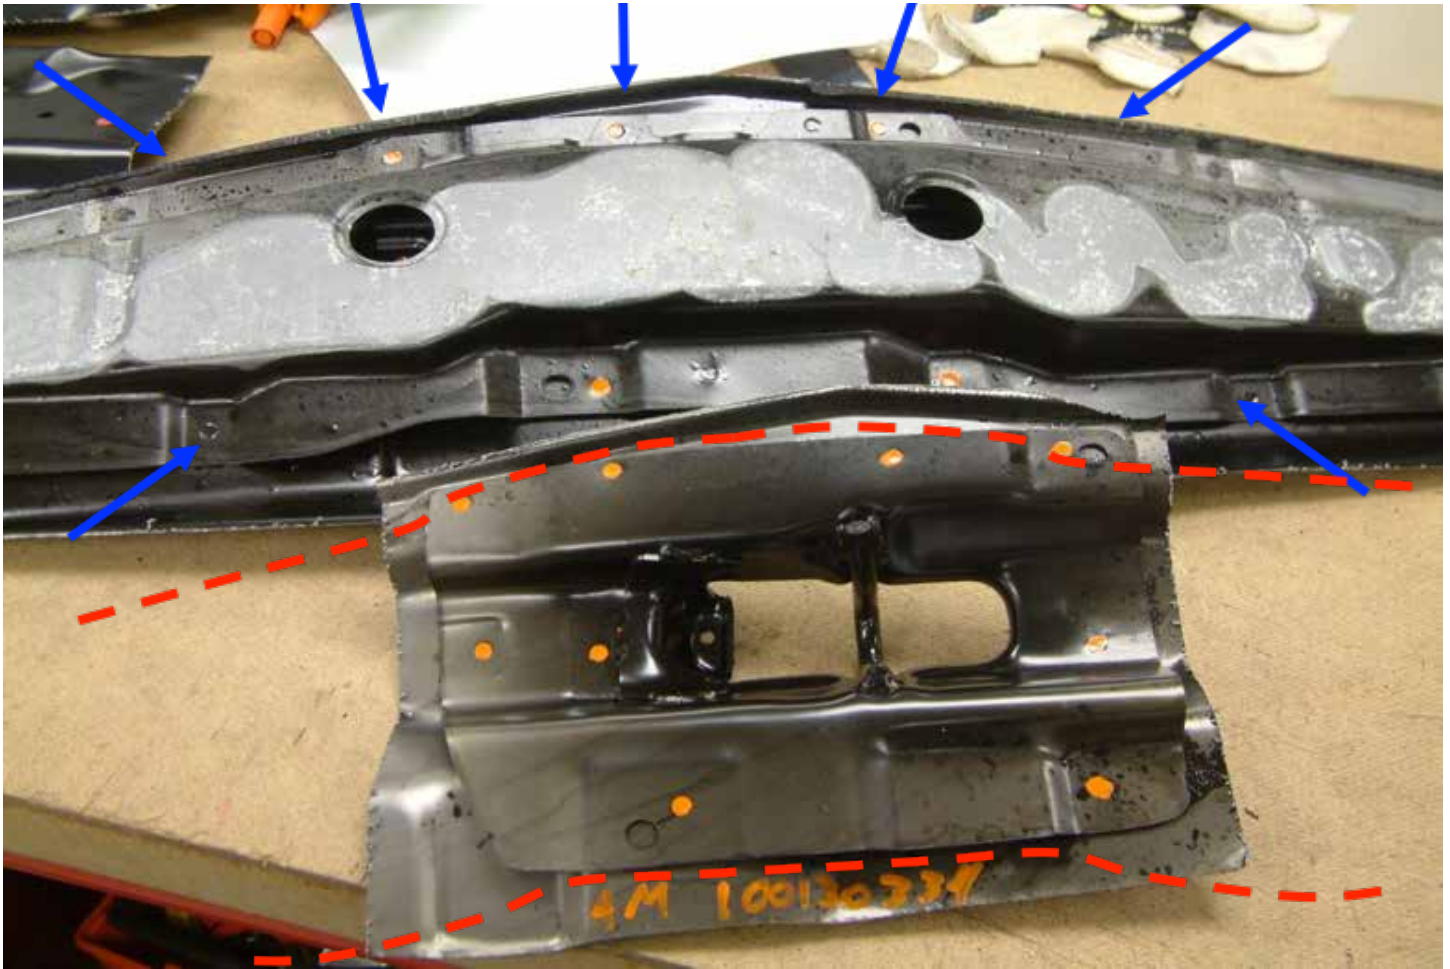
**Figure 2: Missing Striker Reinforcement Plate**

These are portions of the inner skins of a car company brand (upper) and non-CAPA Certified aftermarket (lower) hood for the Dodge Stratus Coupe 03-05. The blue arrows indicate the perimeter of the striker reinforcement plate on the car company brand part. The non-CAPA Certified aftermarket part is missing the reinforcement plate entirely; it should have been where the red dotted line is indicated. The striker plate cannot be seen on the finished part, which may explain way this manufacturer chose to leave it off.

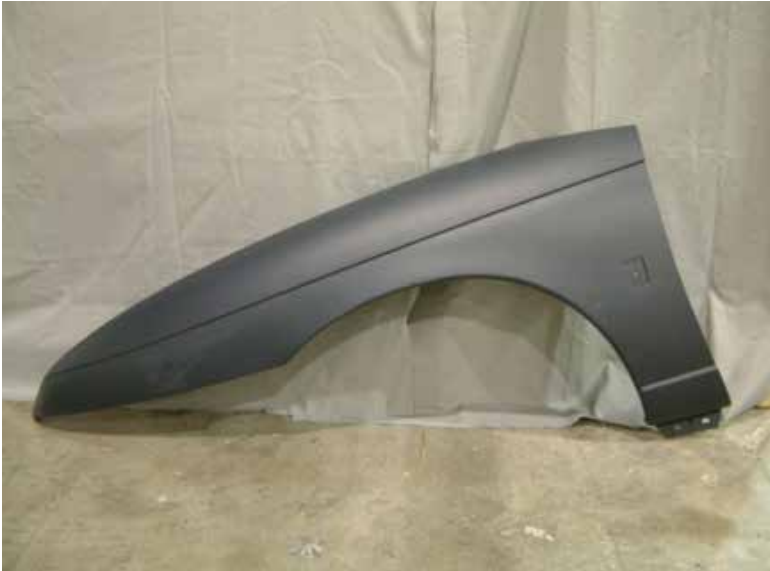
**Figure 3:**  
***Non-CAPA Certified Aftermarket Part  
Saturn S Series 96-99 Fender***

The part is PP (Polypropylene). Even though it visually appears to be “the same” as the car company brand part, it is actually made of a completely different material.

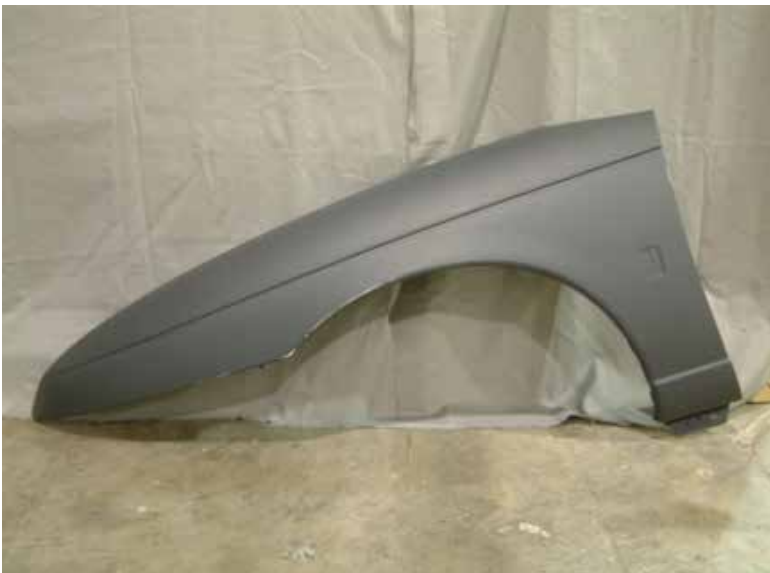
**Figure 4:**  
***Car Company Brand Part  
Saturn S Series 96-99 Fender***

The part is made of PPE + PA (Polyphenylene Ether Blend + Polyamide).

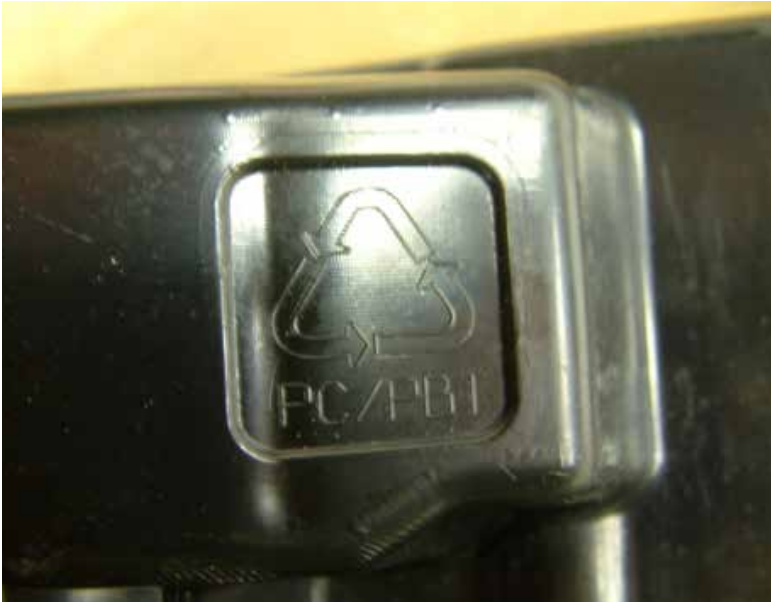
**Figure 5:**  
***Accurate Material ID on Car Company Brand Part***

The material identification "PC/PBT" (Polycarbonate / Polybutylene Terephthalate) molded into the car company brand energy absorber for the Ford Fusion 06-09.

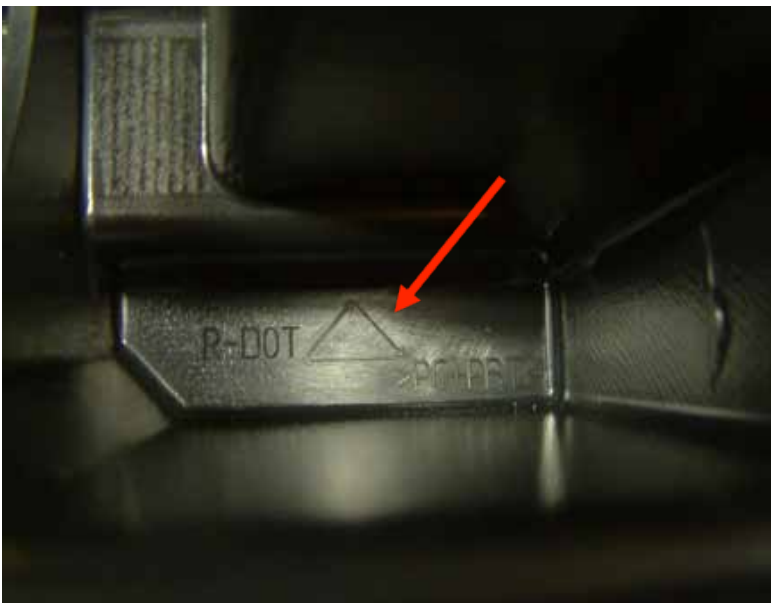
**Figure 6:**  
***Fraudulent Material Marking on Non-CAPA Certified Aftermarket Part***

- In the case of the Ford Fusion 06-09 plastic Energy Absorber, the non-CAPA Certified aftermarket part's flexural strength was 53% less than the car company brand part. This extreme variation may be attributed to the difference in material used to make the parts: the non-CAPA Certified aftermarket part was made of ABS (Acrylonitrile Butadiene Styrene) and the Ford part was made of PC/PBT (Polycarbonate / Polybutylene Terephthalate). To see how differently the non-CAPA Certified aftermarket and Ford energy absorbers performed during an impact test, visit the CAPA website at <http://www.CAPAcertified.org/crash/>. In this comparative test, the non-CAPA Certified part literally shattered upon impact. In addition, the non-CAPA Certified aftermarket part was falsely identified as being made of "PC+PBT."

The material identification, indicated by the red arrow, "PC+PBT" (Polycarbonate / Polybutylene Terephthalate) molded into the non-CAPA Certified aftermarket energy absorber for the Ford Fusion 06-09. The part is actually made of ABS (Acrylonitrile Butadiene Styrene).

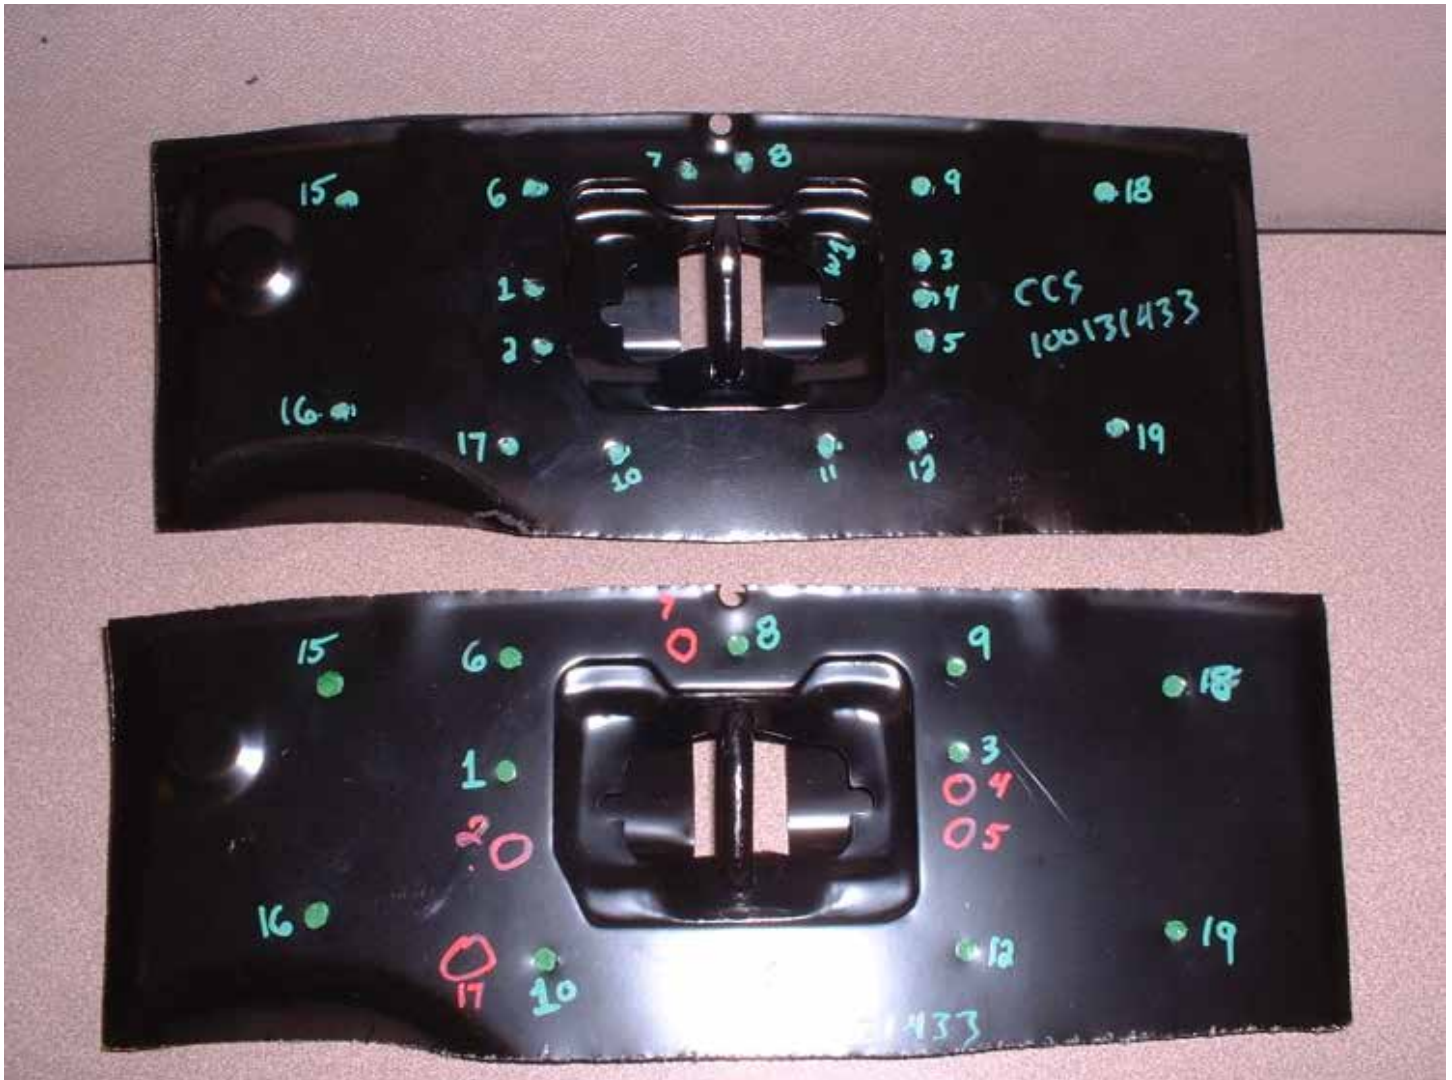
**Figure 7: Missing Welds**

These are the hood striker areas of a car company brand (upper) and non-CAPA Certified aftermarket (lower) hood for the Chevrolet Tracker 99-04. The numbered circles in red on the non-CAPA Certified aftermarket part indicate missing welds when compared to the car company brand part.

Missing welds indicate that the strength of the welded connections found on the aftermarket part will be less than that of the car company brand part. Changes in the weld pattern and weld method indicate that the aftermarket part will perform differently than the car company brand part because stress applied to the part will be transferred differently, which is particularly significant in the case of structural parts.

CAPA requires that size, strength, position, and method of welds on the aftermarket part match those of the car company brand part.

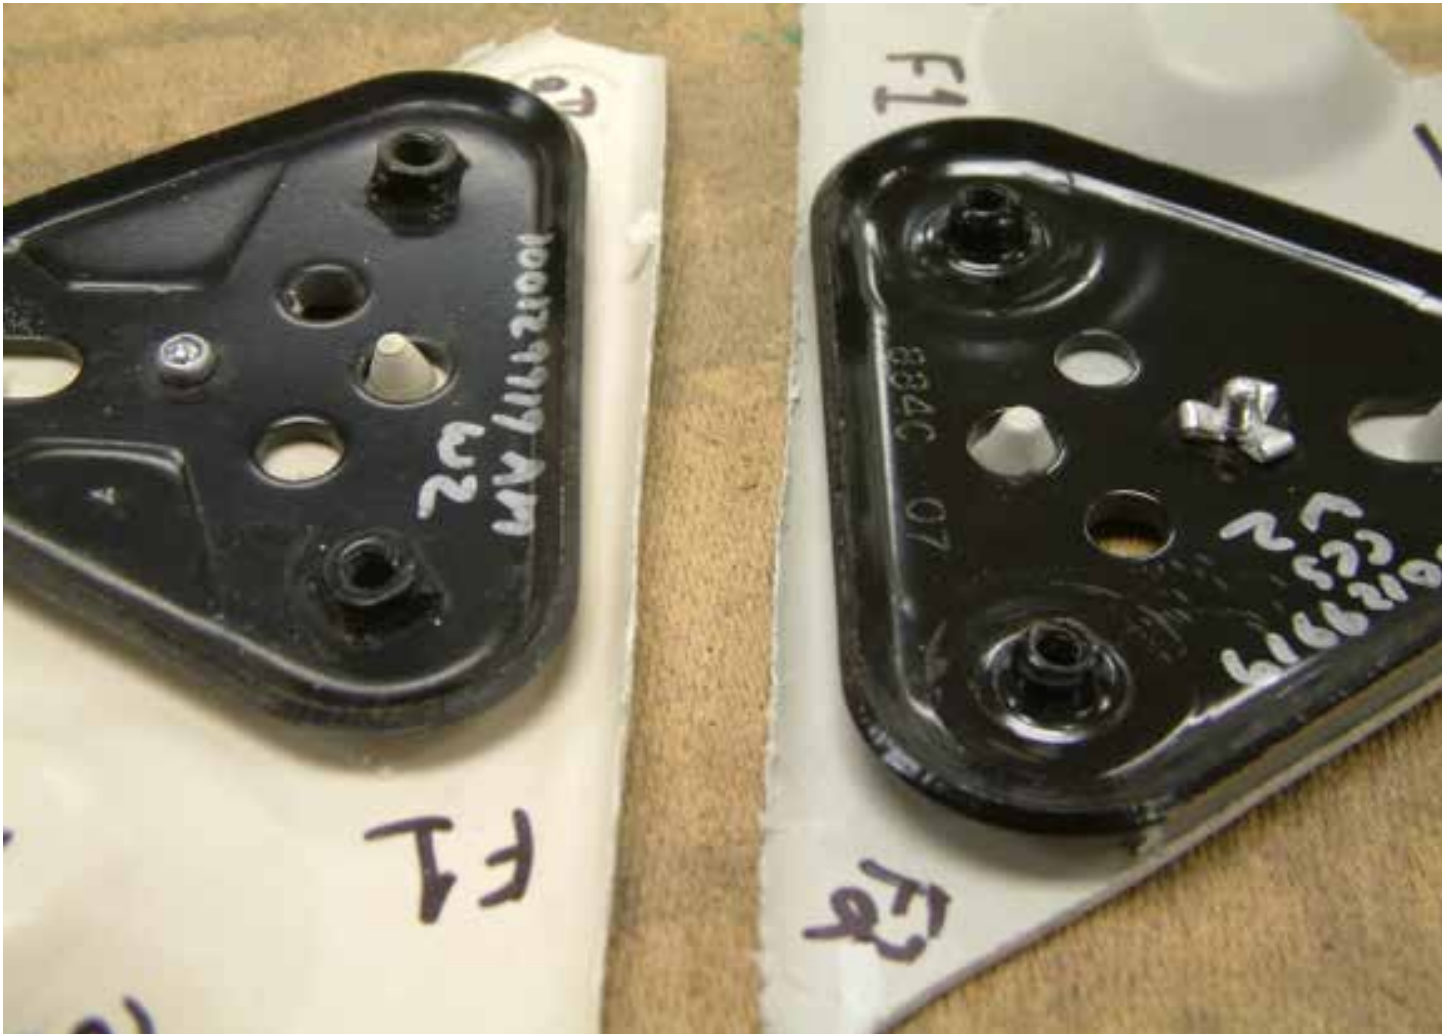
**Figure 8: Different Fastener Construction**

- In the case of the Chrysler Sebring Convertible 96-00 Hood, the average fastener retention of the non-CAPA Certified aftermarket part was 48% less than the car company brand part. The non-CAPA Certified aftermarket part used a different type of fastener than the car company brand part.

Hinge fasteners with low retention strength may break during installation.

These are the hood hinge fasteners of a car company brand (right) and non-CAPA Certified aftermarket (left) hood for the Chrysler Sebring Convertible 96-00. The non-CAPA Certified aftermarket part uses projection weld nuts and the car company brand part uses extruded and threaded fasteners.
