Quality**Watch**

A Periodic Report on Non-CAPA Certified
Aftermarket Replacement Parts

Report Number 2

February 2012

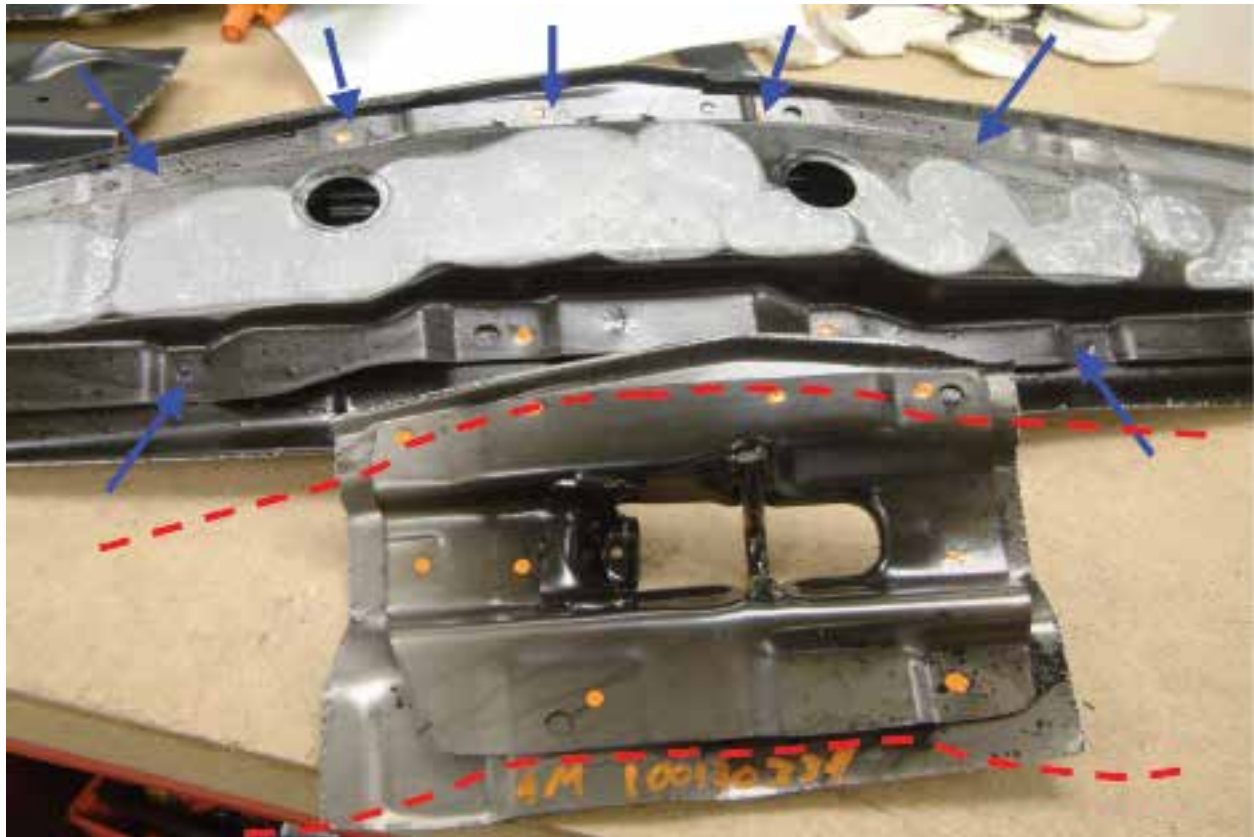
Figure 1: Missing Striker Reinforcement Plate

One of the car company brand hoods was designed using a reinforcement plate. This plate is located in the front of the hood between the striker and the outer skin. The non-CAPA Certified aftermarket part was completely missing this critical reinforcement plate. This same problem was uncovered with another part in CAPA Quality Watch Report #1.

The reinforcement plate provides structure and support to the outer skin in the striker area. Because the reinforcement plate is located between the inner and outer skins of the hood, its presence or absence cannot be seen by simply looking at the hood. For an aftermarket part to meet CAPA requirements, all construction features of the car company service part must be present and tested for comparability to the car company brand part.

These are portions of the inner skins of a car company brand (upper) and non-CAPA Certified aftermarket (lower) hood for the Dodge Stratus Coupe 03-05. The blue arrows indicate the perimeter of the striker reinforcement plate on the car company brand part. The non-CAPA Certified aftermarket part is missing the reinforcement plate entirely; it should have been where the red dotted line is indicated. The striker plate cannot be seen on the finished part, which may explain way this manufacturer chose to leave it off.

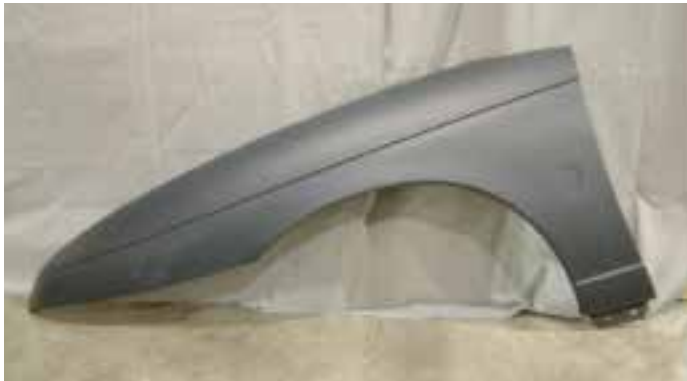
Figure 2: Non-CAPA Certified Aftermarket Part

All three of the non-CAPA Certified **cosmetic plastic aftermarket parts** did not meet CAPA requirements for thickness, strength, and/or impact resistance. In the case of the Chrysler Sebring Convertible 99-00 Hood, the flexural strength of the non-CAPA Certified aftermarket part was 32% less and the tensile strength 33% less than the car company brand part. In the case of the Saturn S Series 96-99 Fender, the flexural strength of the non-CAPA Certified aftermarket part was 72% less and the tensile strength 66% less than the car company brand part. This extreme variation may be attributed to the difference in material used to make the parts: the non-CAPA Certified aftermarket part was made of PP (Polypropylene) and the Saturn part was made of PPE + PA (Polyphenylene Ether Blend + Polyamide).

**Saturn S Series 96-99 Fender**

The part is PP (Polypropylene). Even though it visually appears to be “the same” as the car company brand part, it is actually made of a completely different material.

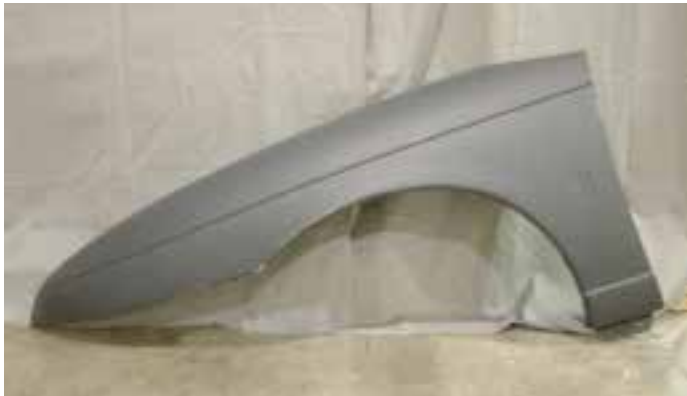
Figure 3: Car Company Brand Part

**Saturn S Series 96-99 Fender**

The part is made of PPE + PA (Polyphenylene Ether Blend + Polyamide).

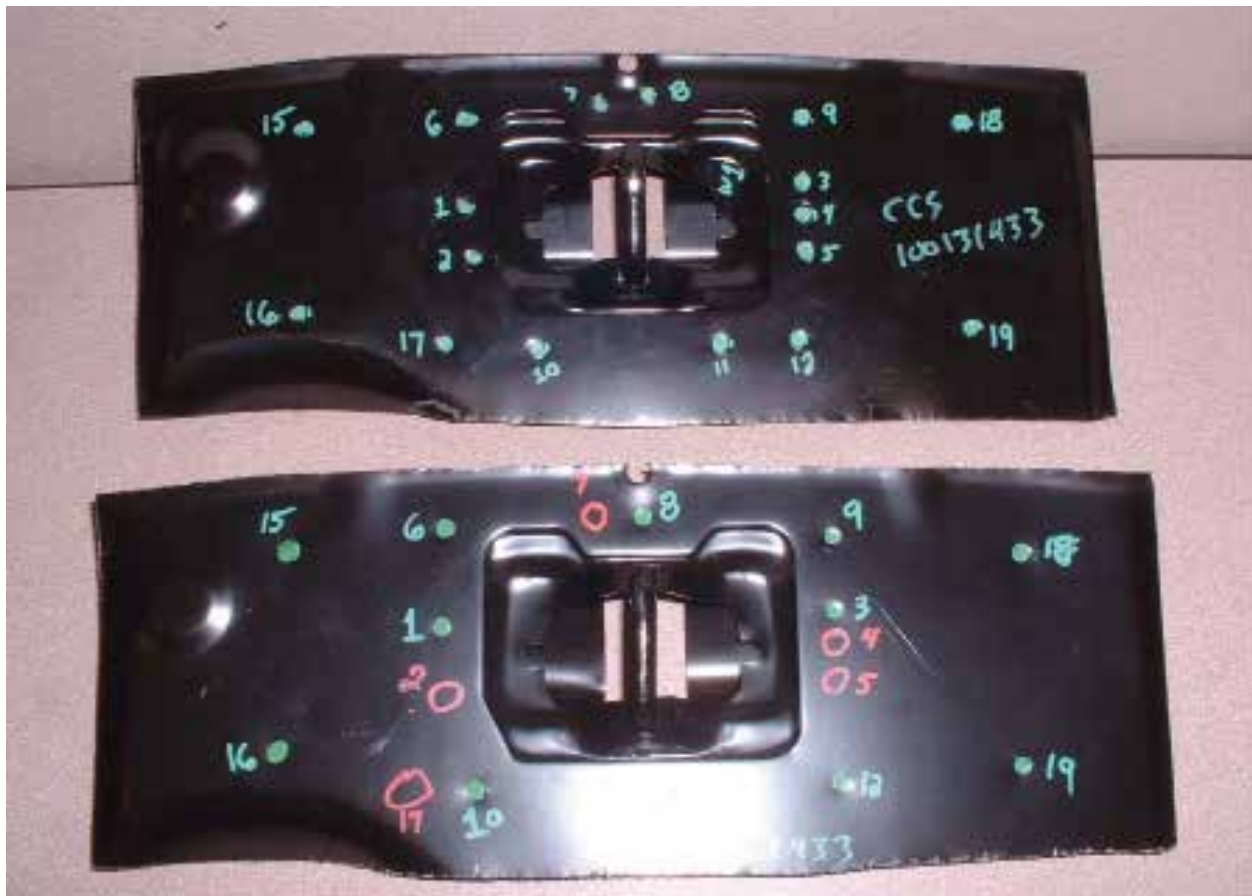
Figure 4: Missing Welds

The size of the spot welds in the striker areas of two of the hoods were tested. Both of the non-CAPA Certified aftermarket parts did not meet CAPA requirements for weld size when compared to the car company brand parts. This is significant because weld size equals weld strength: smaller welds mean weaker welds.

Two of the non-CAPA Certified aftermarket parts were missing welds when compared to the car company brand parts. In the case of the Chevrolet Tracker 99-04 Hood, the non-CAPA Certified aftermarket part was missing 37% of the welds present on the car company brand part. Missing welds indicate that the strength of the welded connections found on the aftermarket part will be less than that of the car company brand part.

These are the hood striker areas of a car company brand (upper) and non-CAPA Certified aftermarket (lower) hood for the Chevrolet Tracker 99-04. The numbered circles in red on the non-CAPA Certified aftermarket part indicate missing welds when compared to the car company brand part.

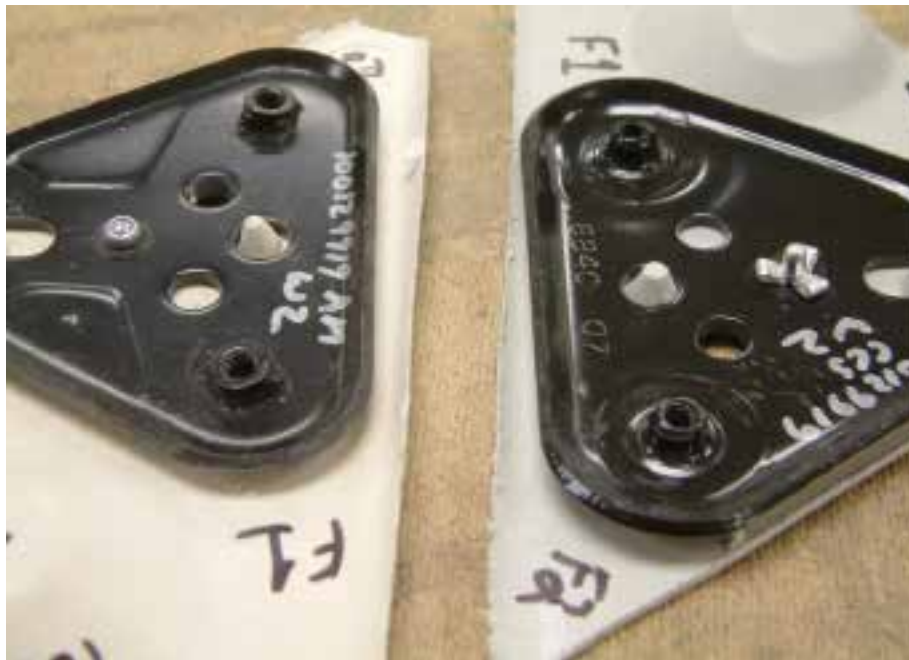
Figure 5: Different Fastener Construction

The variations between the non-CAPA Certified aftermarket and car company brand parts were significant. In the case of the Chrysler Sebring Convertible 96-00 Hood, the average fastener retention of the non-CAPA Certified aftermarket part was 48% less than the car company brand part. The non-CAPA Certified aftermarket part used a different type of fastener than the car company brand part. Hinge fasteners with low retention strength may break during installation. In the case of the Chevrolet Silverado 99-07 Left and Right Bumper Brackets, the fastener retention of the non-CAPA Certified aftermarket parts were 53% and 56%, respectively, less than the car company brand parts.

These are the hood hinge fasteners of a car company brand (right) and non-CAPA Certified aftermarket (left) hood for the Chrysler Sebring Convertible 96-00. The non-CAPA Certified aftermarket part uses projection weld nuts and the car company brand part uses extruded and threaded fasteners.
