**CAPA**

# Quality**Watch**

A Periodic Report on Non-CAPA Certified  
Aftermarket Replacement Parts

## **Report Number 1**

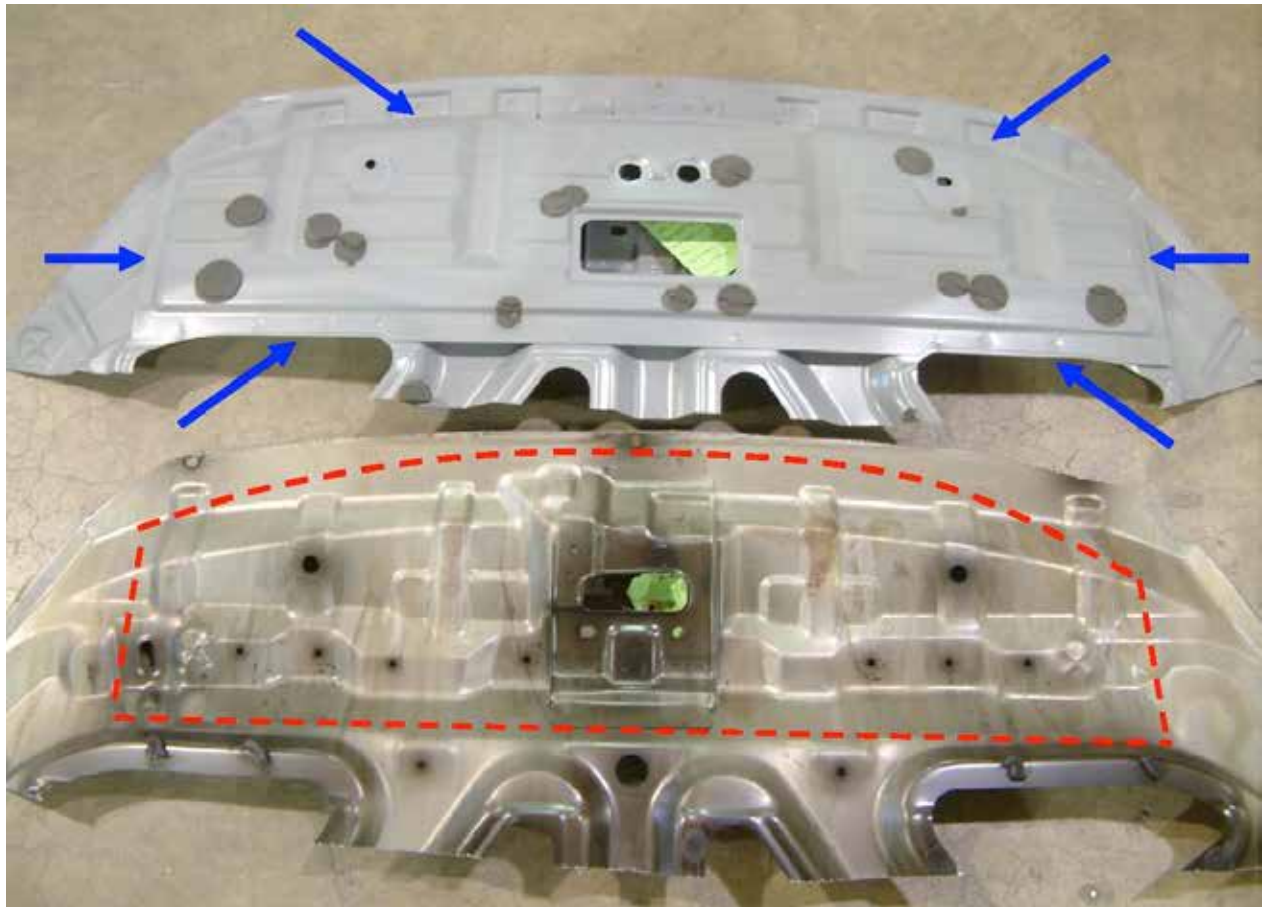
## Figure 1: Missing Striker Reinforcement Plate

One of the car company brand hoods was designed using a reinforcement plate. This plate is located in the front of the hood between the striker and the outer skin. The non-CAPA Certified aftermarket part was completely missing this critical reinforcement plate.

The reinforcement plate provides structure and support to the outer skin in the striker area. Because the reinforcement plate is located between the inner and outer skins of the hood, its presence or absence cannot be seen by simply looking at the hood. For an aftermarket part to meet CAPA requirements, all construction features of the car company service part must be present and tested for comparability to the car company brand part.

— These are portions of the inner skins of a car company brand (upper) and non-CAPA Certified aftermarket (lower) hood for the Kia Rio Sedan 03-05. The blue arrows indicate the perimeter of the striker reinforcement plate on the car company brand part. The non-CAPA Certified aftermarket part is missing the reinforcement plate entirely, as indicated by the red dotted line.

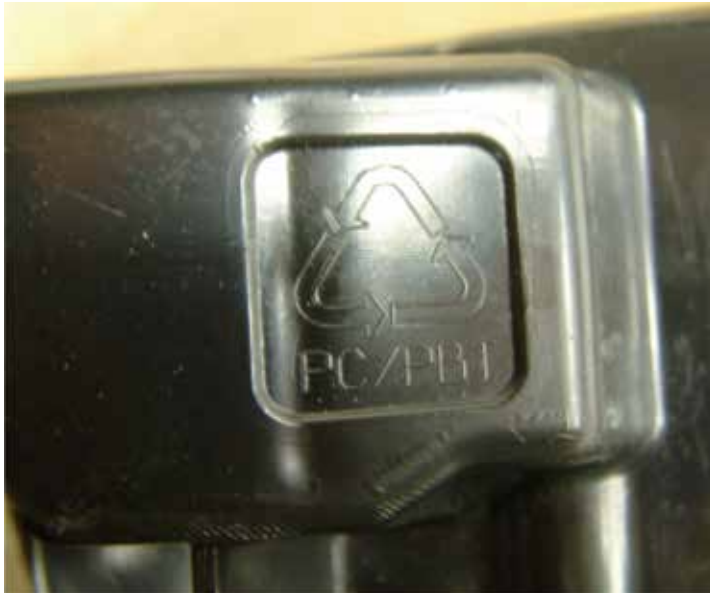
**Figure 2: Accurate Material ID on Car Company Brand Part**

The material identification "PC/PBT" (Polycarbonate / Polybutylene Terephthalate) molded into the car company brand energy absorber for the Ford Fusion 06-09.

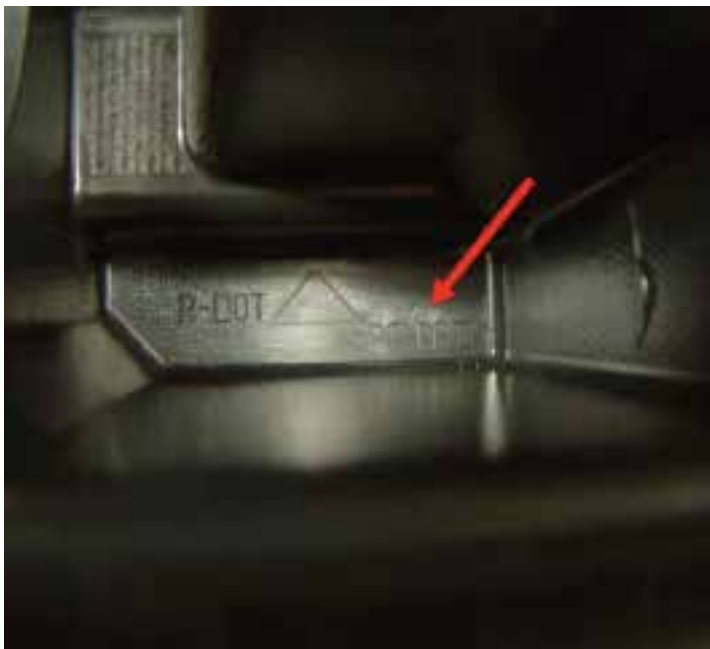
**Figure 3: Fraudulent Material Marking on Non-CAPA Certified Aftermarket Part**

All three of the non-CAPA Certified structural plastic and foam aftermarket parts did not meet CAPA requirements for strength and impact resistance. Again, the variations between the non-CAPA Certified aftermarket and car company brand parts were significant. In the case of the Ford Fusion 06-09 plastic Energy Absorber, the non-CAPA Certified aftermarket part's flexural strength was 53% less than the car company brand part. This extreme variation may be attributed to the difference in material used to make the parts: the non-CAPA Certified part was made of PC/PBT (Polycarbonate / Polybutylene Terephthalate). To see how differently the non-CAPA Certified aftermarket and Ford energy absorbers performed during an impact test, visit the CAPA website at <http://www.CAPAcertified.org/crash/>. In this comparative test, the non-CAPA Certified part literally shattered upon impact. In addition, the non-CAPA Certified aftermarket part was falsely

identified as being made of “PC+PBT.” In the case of the two foam energy absorbers, the non-CAPA Certified aftermarket parts ranged from 51% stronger to 20% weaker when compared to the car company brand parts.

The material identification, indicated by the red arrow, "PC+PBT" (Polycarbonate / Polybutylene Terephthalate) molded into the non-CAPA Certified aftermarket energy absorber for the Ford Fusion 06-09. The part is actually made of ABS (Acrylonitrile Butadiene Styrene).
