**Compliance Test Results
of Independently Manufactured
Automotive Replacement Headlamps
to FMVSS 108
Study I
March 18, 2003**

Certified Automotive Parts Association
1518 K Street NW, Suite 306
Washington, DC 20005

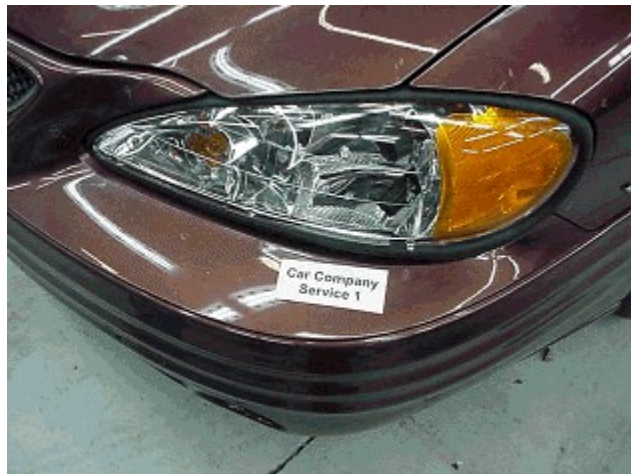
Figure 1. 1999 Pontiac Grand Am exhibiting a LH Headlamp.

Figure 1. and Figure 2. provide views of a Grand Am and Taurus headlamp mounted in the respective vehicles.

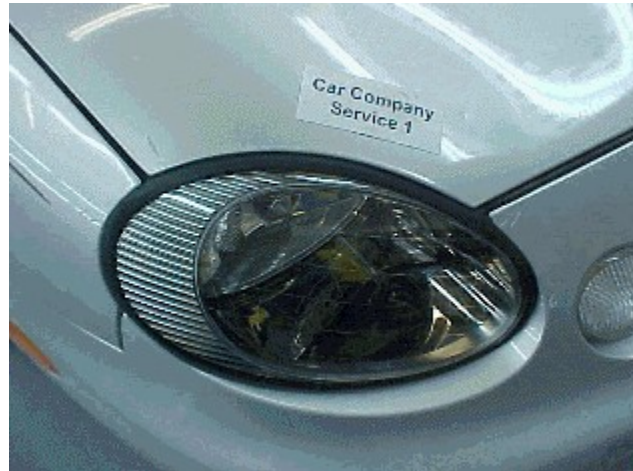
Figure 2. 1997 Ford Taurus exhibiting a RH Headlamp.

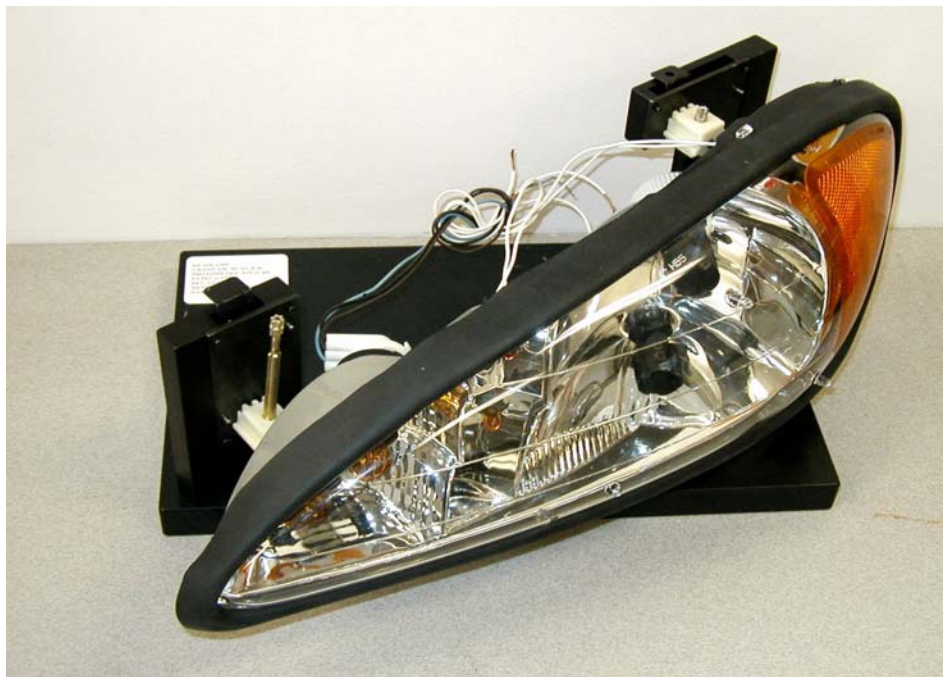
Figure 4. 1999-2003 LH Grand Am headlamp mounted on the photometric test fixture.

Figure 3. illustrates the 1999-2003 LH Grand Am headlamp photometric fixture drawing, and Figure 4. shows the completed fixture with a mounted headlamp.

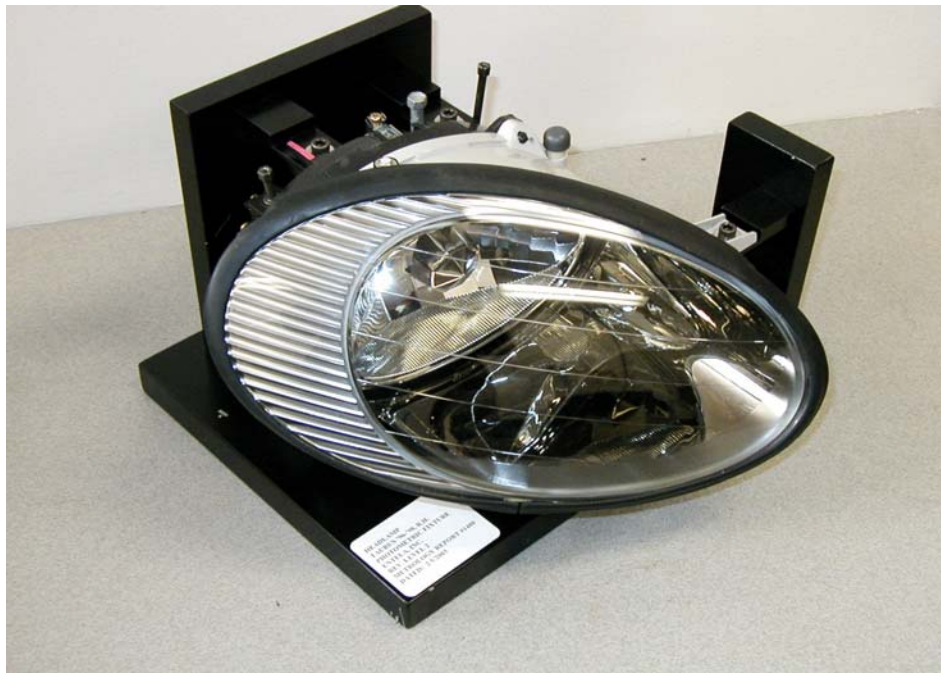
Figure 6. 1996-1998 RH Taurus headlamp mounted on the photometric test fixture.

Figure 5. illustrates the 1996-1998 RH Taurus headlamp photometric fixture drawing, and Figure 6. shows the completed fixture with a mounted headlamp.

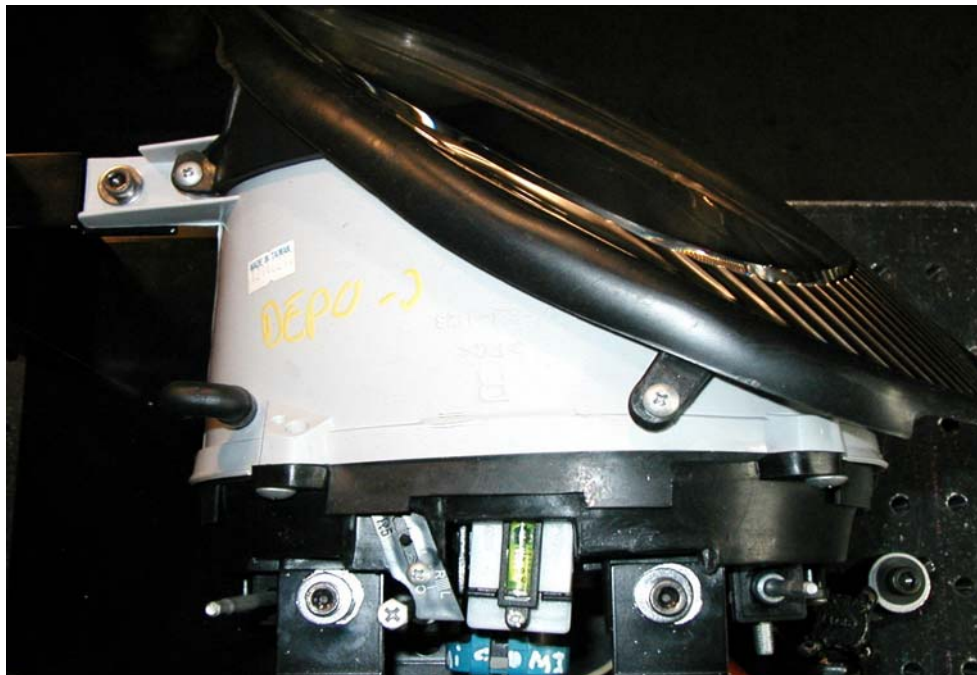
Figure 9. Top view of a DEPO manufactured Taurus headlamp. The bubble level (located near the bottom center) is a vertical VHAD used for setting the vertical aim.

The Ford Taurus employs a bubble level located at the top rear center of the lamp (Figure 9). This bubble level functions as a vertical orientation VHAD. This level is affixed to a portion of the plastic reflector inside the lamp that moves as the vertical aiming screw is turned.

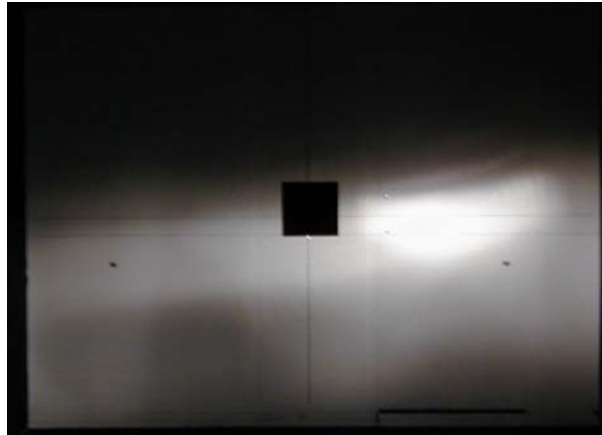
Figure 13. A TYC Grand Am low beam when aimed using the lens exterior aiming pads.

Figures 12., 13., and 14. provide digital photographic comparisons between the Grand Am original equipment manufacturer (OEM) replacement, TYC, and DEPO low beam patterns when aimed in accordance with FMVSS 108.

It is feasible for a range of beam patterns to fall within the FMVSS 108 requirements. However, beam patterns displayed in Figures 13., 14., 16., and 17., do not meet the FMVSS 108 requirements when evaluated using the photometric test instrumentation.

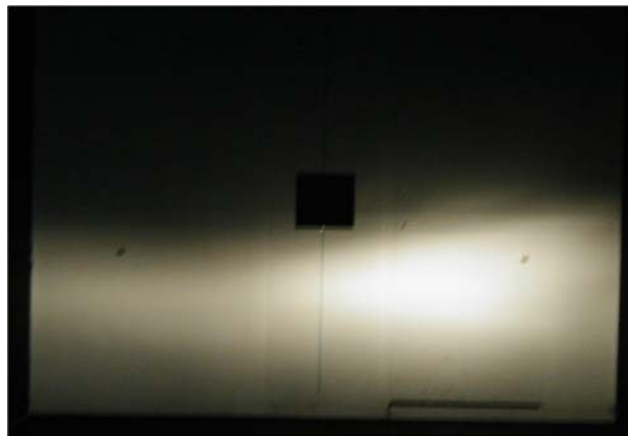
Figure 15. A Taurus original equipment manufacturer (OEM) replacement low beam pattern aimed with the vertical VHAD.

Figures 15., 16., and 17. provide digital photographic comparisons between the Taurus original equipment manufacturer (OEM) replacement, TYC, and DEPO low beam patterns when aimed in accordance with FMVSS 108.

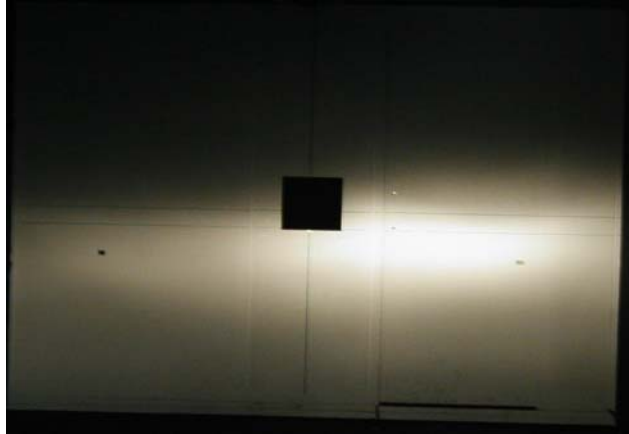
Figure 16. A TYC Taurus low beam pattern aimed with the vertical VHAD.
