**Compliance Test Results
of Independently Manufactured
Automotive Replacement Headlamps
To FMVSS 108
Study II
May 13, 2004**

Certified Automotive Parts Association
1518 K Street NW, Suite 306
Washington, DC 20005

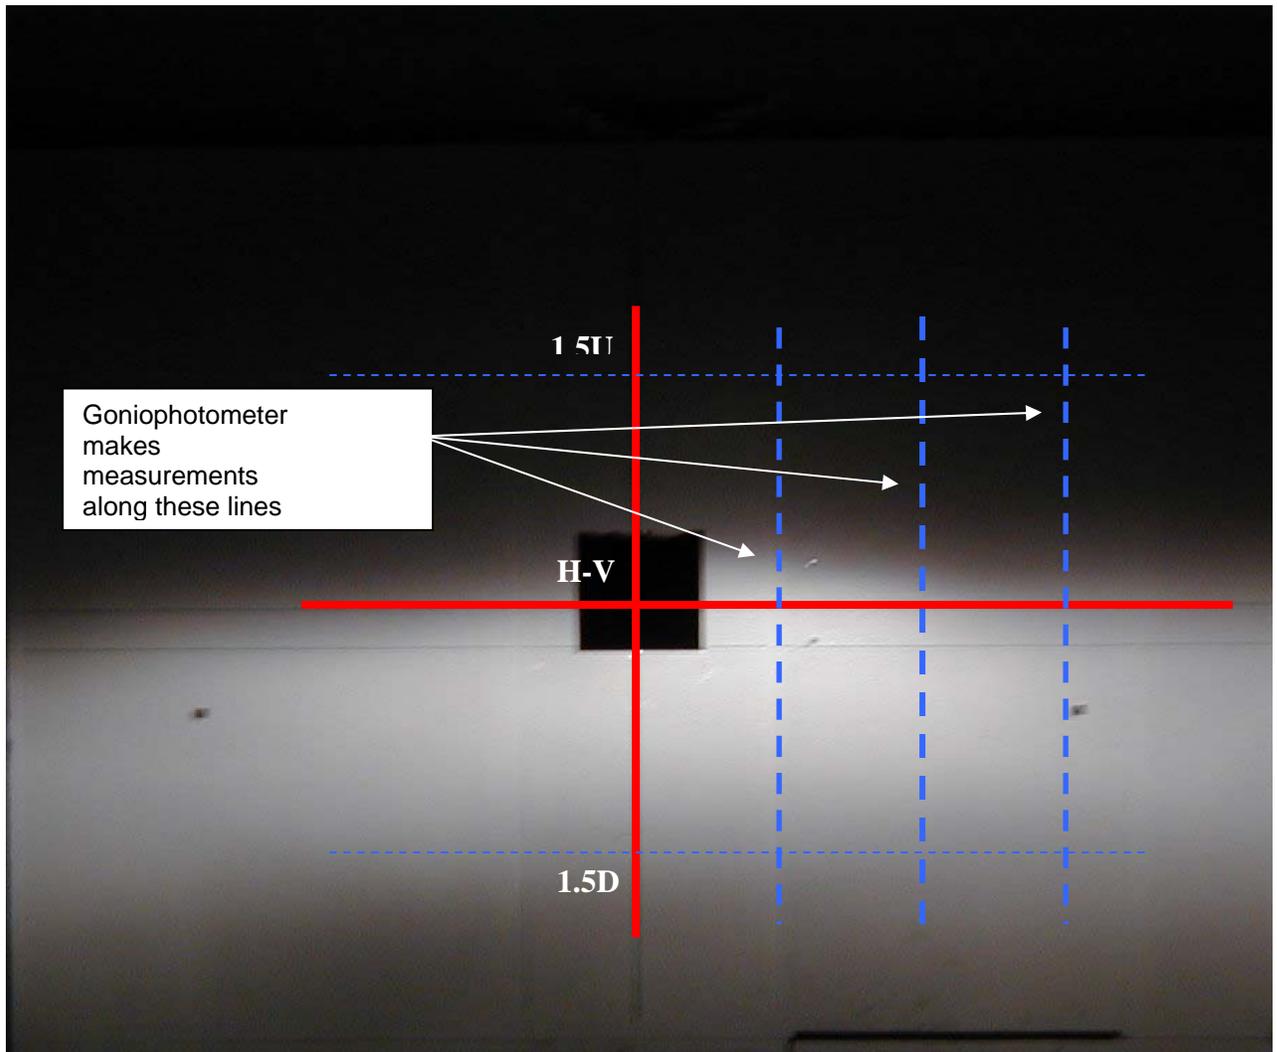
Figure 1. Representation of the VOR aiming grid laid over a headlamp beam pattern. Proper vertical aim of the headlamp is carried out by the goniophotometer.

FMVSS 108 provides aiming instructions and criteria for the range of acceptable aiming devices incorporated into automotive headlamps. Both of the lights included in this study are aimed using a procedure referenced as Visual Optical Left (VOL) or Visual Optical Right (VOR). In order to eliminate any visual subjectivity, Visual Optical aiming is performed by a computer, which positions the beam horizontally and vertically on a target surface in the photometric laboratory based on the characteristics of its illuminated pattern. Both the Ford Taurus and Toyota Camry in this study employ the use of VOR aim. Since lamps are aimed based on their beam pattern characteristics, it is possible for a beam pattern to fail intensity requirements that are needed in order to position it accurately. As a result, a headlamp may be photometrically non-conformant in the aiming stage of the testing.

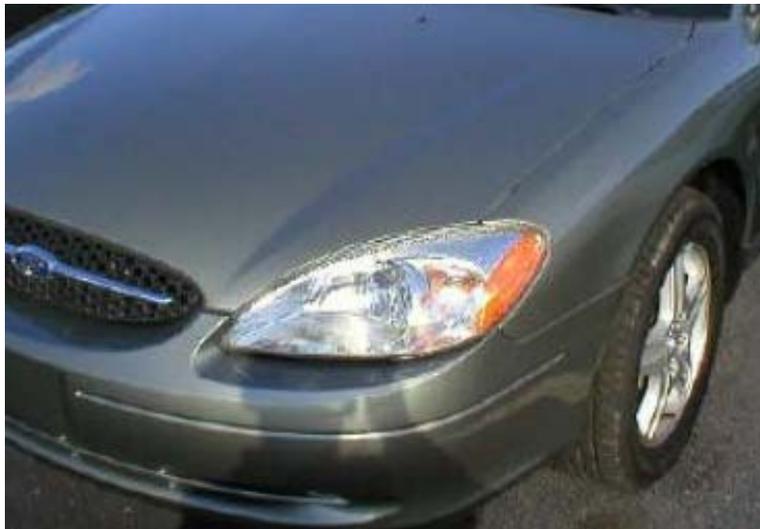
Figure 2. 2003 Ford Taurus exhibiting a LH Headlamp.

Figure 2. and Figure 3. provides views of a 2003 Ford Taurus and 2001 Toyota Camry headlamp mounted in the respective vehicles.

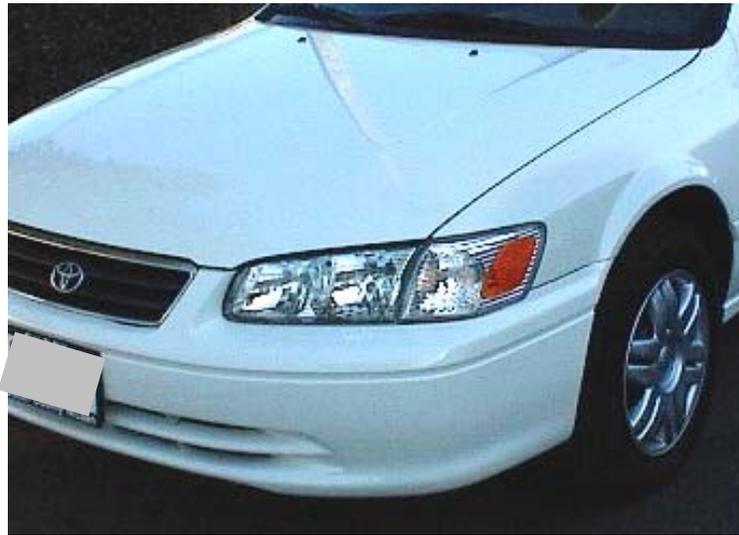
Figure 3. 2001 Toyota Camry exhibiting a LH Headlamp.

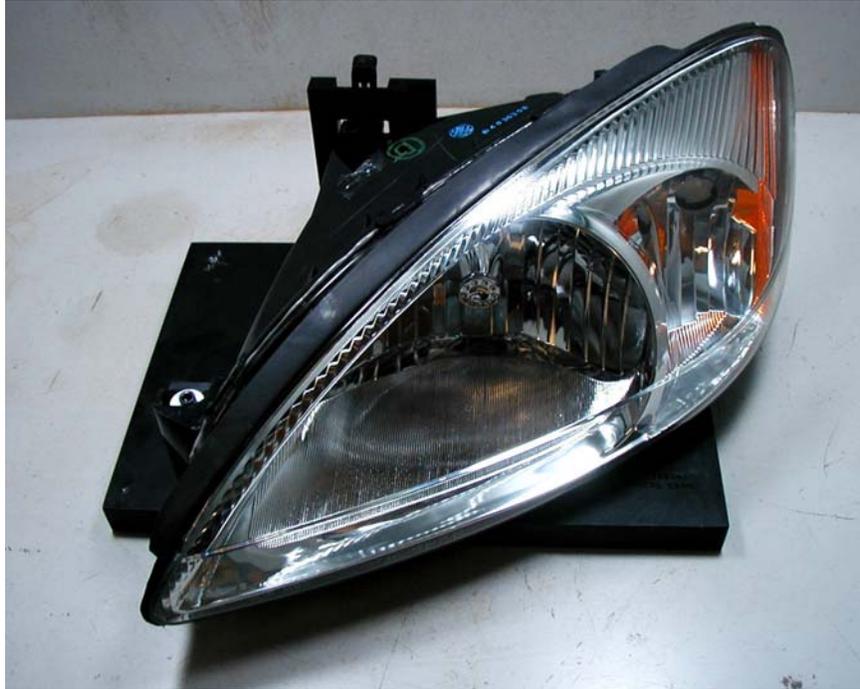
Figure 5. 2000-2003 LH Ford Taurus headlamp mounted on the photometric test fixture.

Vehicle headlamp mounting locations were measured using a Coordinate Measurement Machine (CMM). The “in-vehicle” position photometric fixtures were developed from the vehicle measurements using 3-D computer aided design (CAD) software.

Figure 4. illustrates the 2000-2003 LH Ford Taurus headlamp photometric fixture drawing, and Figure 5. shows the completed fixture with a mounted headlamp.

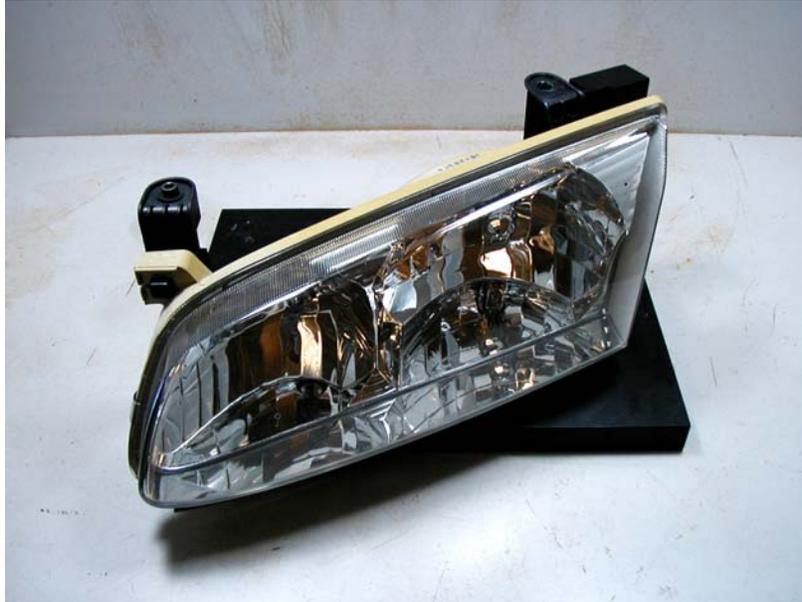
Figure 7. 2000-2001 LH Toyota Camry headlamp mounted on the photometric test fixture.

Figure 6. illustrates the 2000-2001 LH Toyota Camry headlamp photometric fixture drawing, and Figure 7. shows the completed fixture with a mounted headlamp.

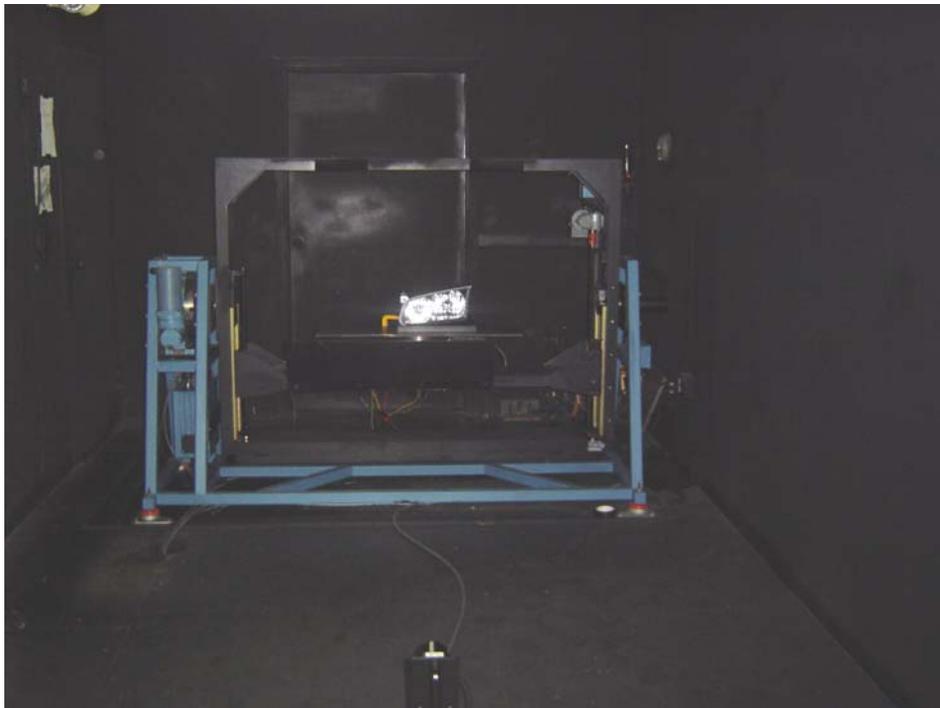
Figure 8. Photometric laboratory instrumentation with a headlamp mounted on the goniometer table. The photometric sensor is located 100 feet from the center of the headlamp's bulb filament at the opposite end of the tunnel.

The photometric testing was performed in accordance with FMVSS 108 and the associated SAE standards using a Hoffman goniophotometer (Figure 8). The headlamp samples were mounted on the photometric fixture and then attached to the goniometer. The filament of the bulb was aligned with the axis of the goniometer and the photometric sensor using a laser system incorporated in the goniometer/photometer set-up. The lamp was then aimed at the photometric sensor using the VOR aiming method detailed in the Technical Background section of this report.

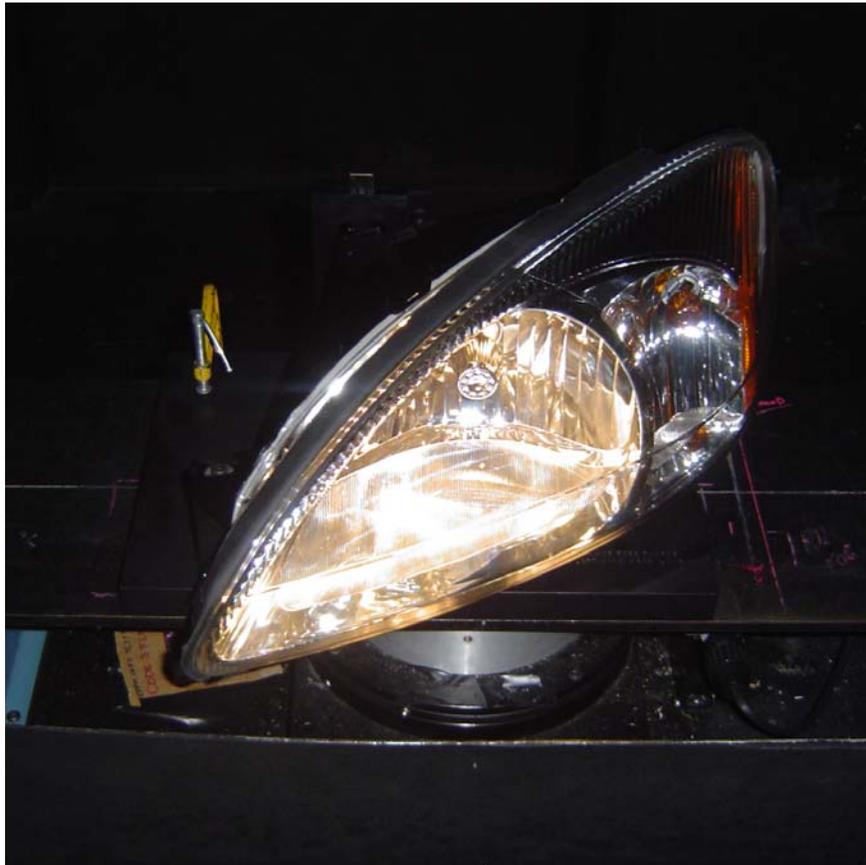
Figure 9. 2000-2003 LH Ford Taurus headlamp mounted to the goniometer table.

Figure 9. and Figure 10. illustrate the Ford Taurus and Toyota Camry headlamps respectively mounted to the goniometer table.

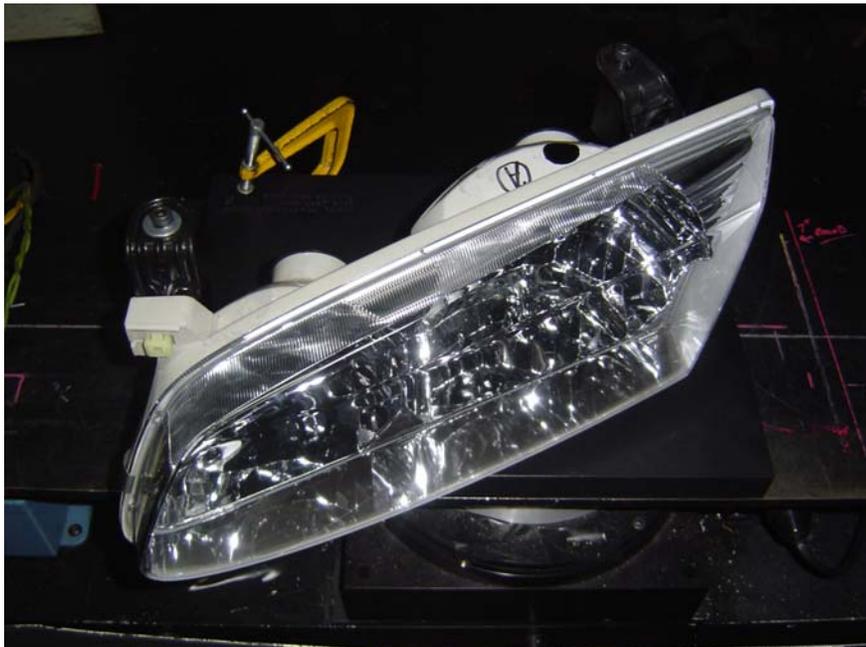
Figure 10. 2000-2001 LH Toyota Camry headlamp mounted to the goniometer table.

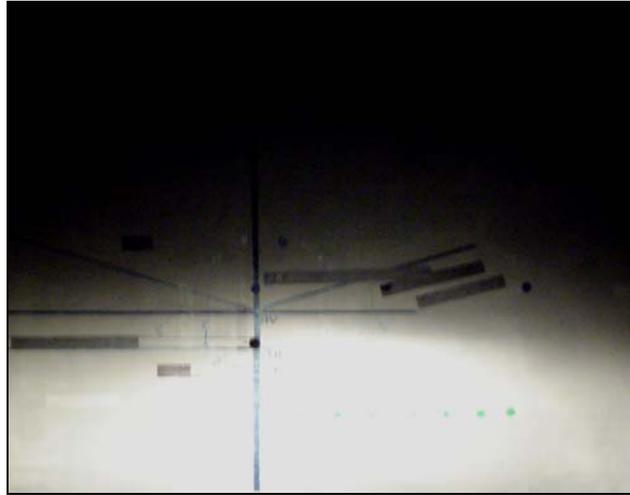
Figure 11. A Ford Taurus original equipment manufacturer (OEM) replacement low beam when aimed using the VOR method.

Figures 11., and 12. provide digital photographic comparisons between the Ford Taurus original equipment manufacturer (OEM) replacement, TYC, and DEPO low beam patterns when aimed in accordance with FMVSS 108.

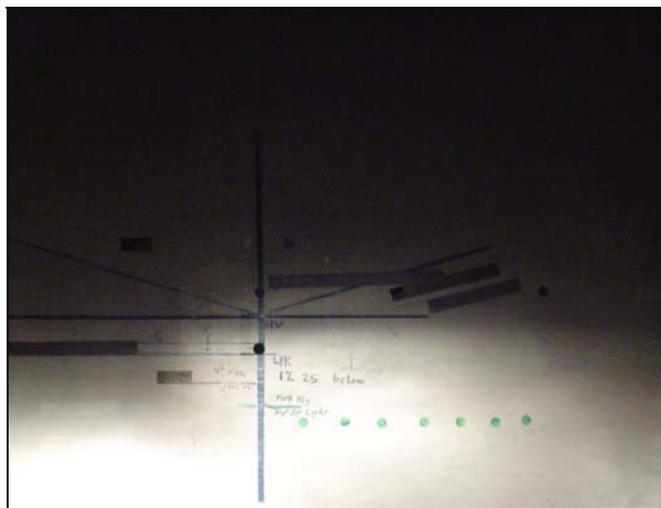
Figure 12. A TYC Ford Taurus low beam when aimed using the VOR method.

It is feasible for a range of beam patterns to fall within the FMVSS 108 requirements. However, beam patterns displayed in Figures 12., 14., and 15. do not meet the FMVSS 108 requirements when evaluated using the photometric test instrumentation.

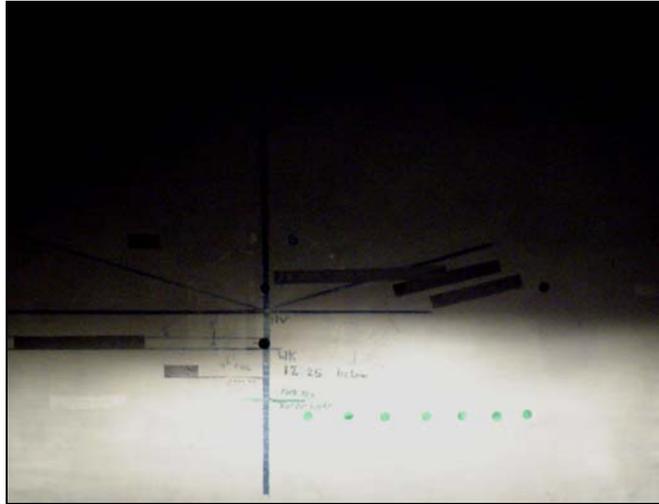
Figure 13. An original equipment manufacturer (OEM) replacement Toyota Camry low beam pattern aimed using the VOR method.

Figures 13., 14., and 15. provide digital photographic comparisons between the Toyota Camry original equipment manufacturer (OEM) replacement, TYC, and DEPO low beam patterns when aimed in accordance with FMVSS 108.

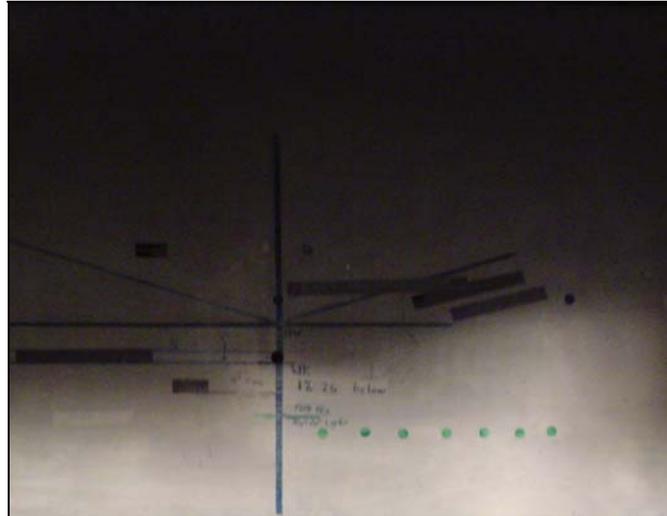
Figure 14. A TYC Toyota Camry low beam pattern aimed using the VOR method.

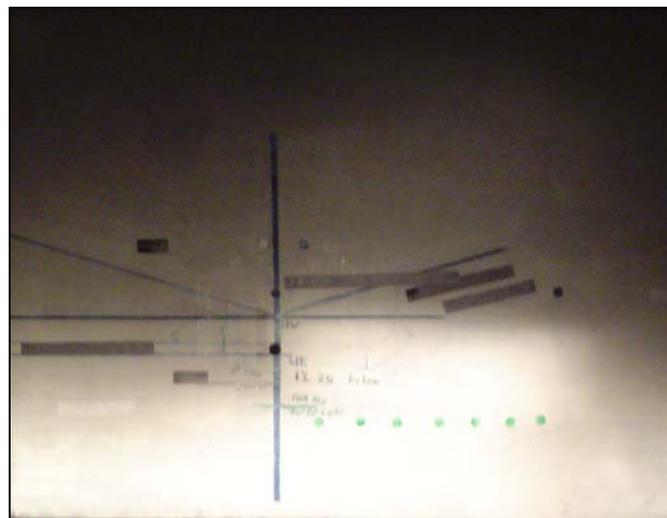
Figure 15. A DEPO Toyota Camry low beam pattern aimed using the VOR method.
