# **Car Company Quality: A Vehicle Test Fit Study of 1,907 Car Company Service Parts**

**Study Dates: March 1999 – March 2002**

# Car Company Quality Vehicle Test Fit Study

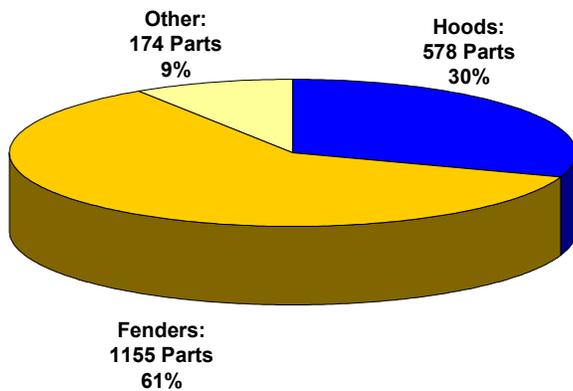
**CHART 1**  
**CAR COMPANY PART TYPES**  
**INCLUDED IN STUDY**  
**(1,907 PARTS)**

“Other” includes part types such as tailgates and bumper covers.

The population of the car company service parts included in this report was completely dependent on the population of CAPA parts, i.e. a car company service part was test fit only if it was the counterpart of a CAPA part that was being tested. The car company service parts were purchased directly from car company dealerships from March 1999 to March 2002. The part types included fenders, hoods, tailgates, and bumper covers. This information may also be viewed at [www.CAPAcertified.org](http://www.CAPAcertified.org).

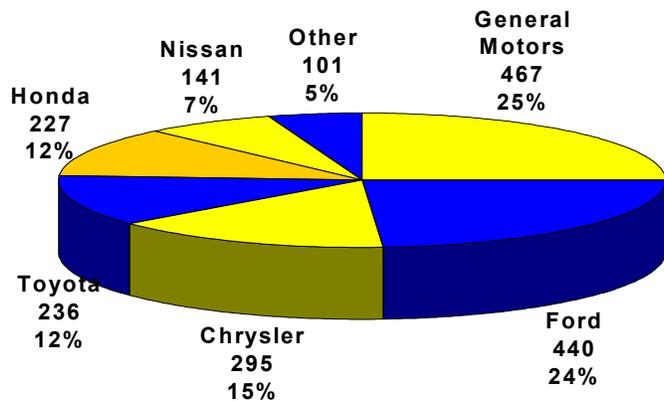
**CHART 2**  
**CAR COMPANY MANUFACTURERS**  
**INCLUDED IN STUDY**  
**(1,907 PARTS)**

“Other” car company manufacturers include BMW, Isuzu, Mazda, Mercedes, Mitsubishi, Suzuki, and Volkswagen.

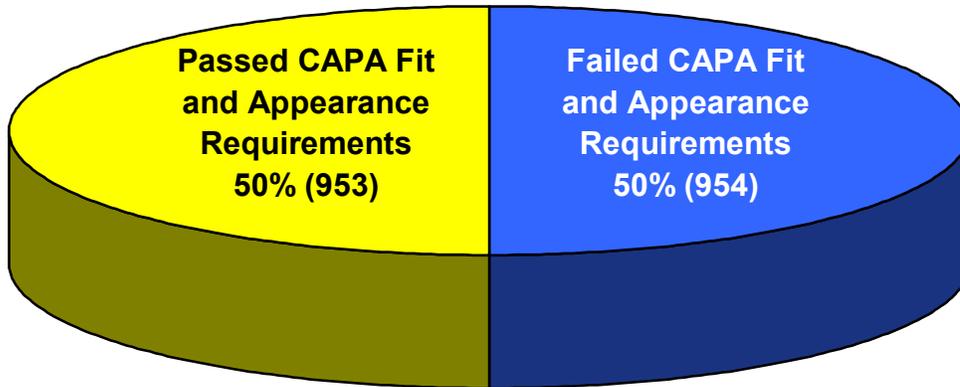
**CHART 3**  
**OVERALL RESULTS**  
**CAR COMPANY SERVICE PART QUALITY STUDY**  
**(1,907 PARTS)**

<u>Overall Summary</u>	<u># of Parts</u>	<u>% of Total</u>
Fail	954	50%
Pass	953	50%
Total Car Company Parts Evaluated	1,907

<u>Failure Types</u>	<u># of Parts</u>	<u>% of Failures</u>
Total Parts Failed*	954	
Fit	511	54%
Appearance	673	71%

\*Parts can fail both Fit and Appearance.

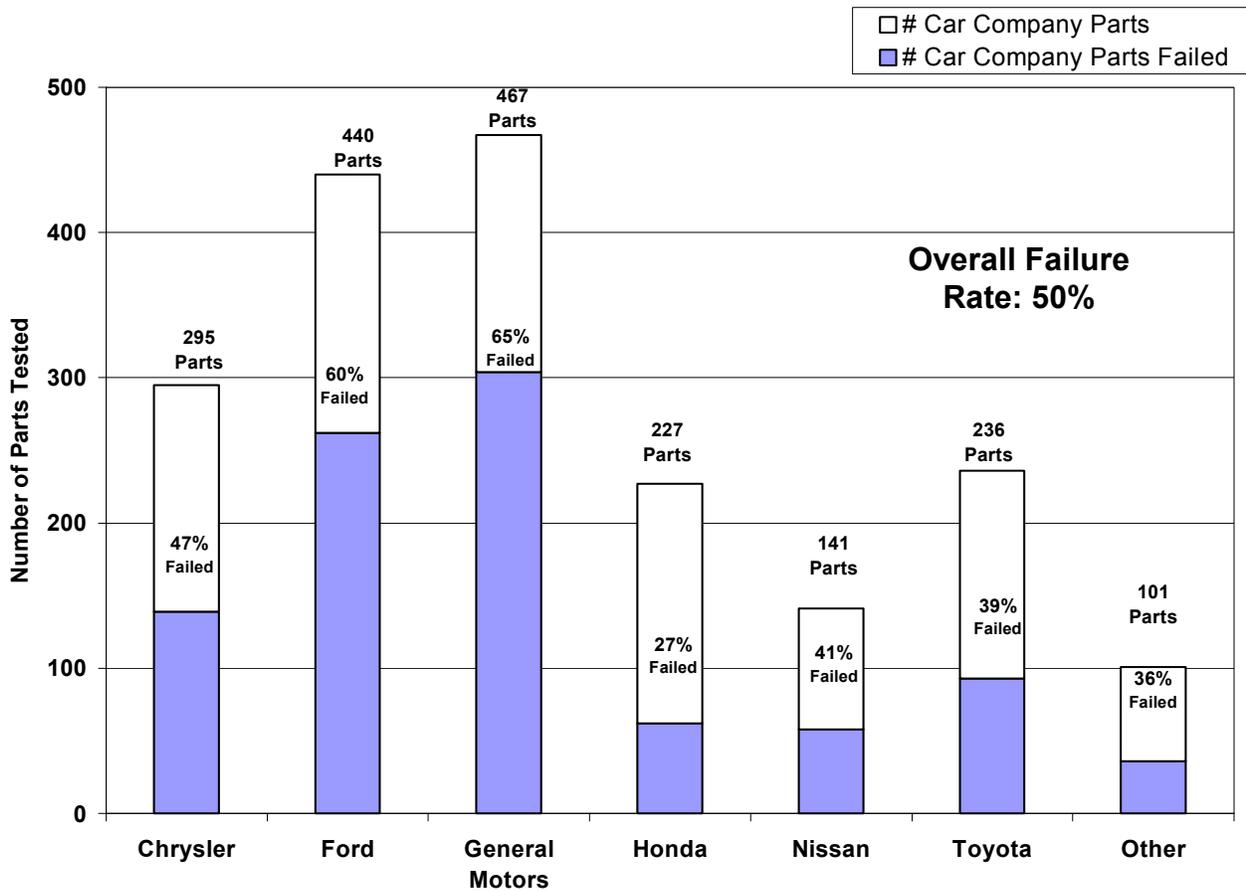
**CHART 4**  
**CAR COMPANY FAILURE RATES**  
**BY MANUFACTURER**  
**(1,907 PARTS)**

“Other” car company manufacturers include BMW, Isuzu, Mazda, Mercedes, Mitsubishi, Suzuki, and Volkswagen.

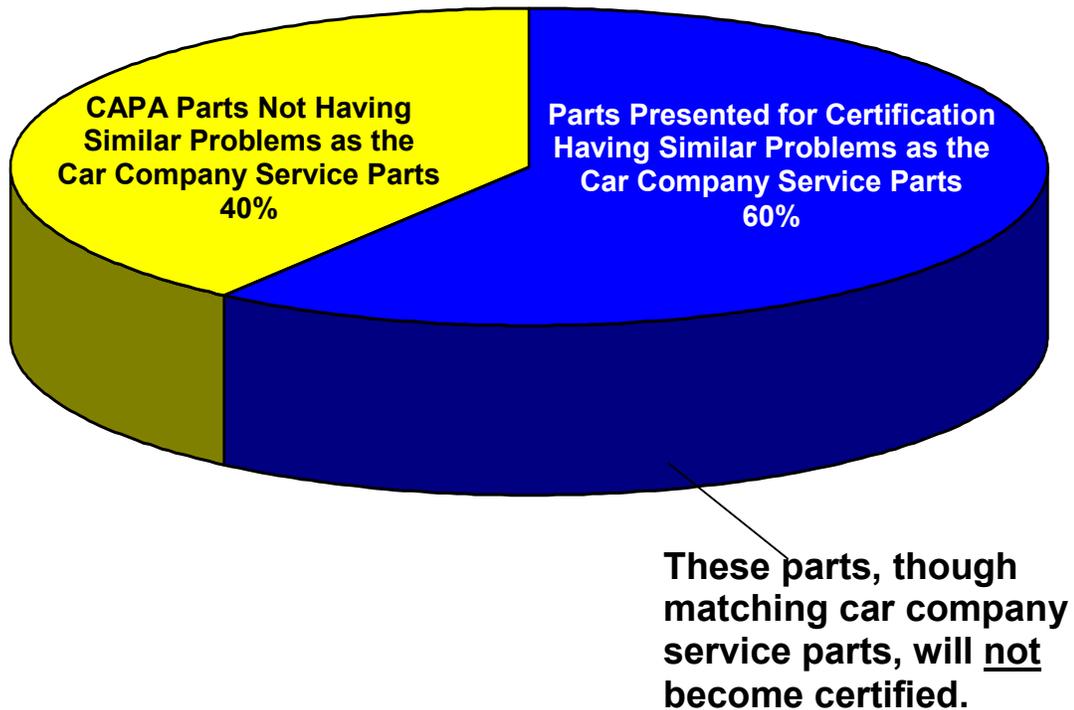
**CHART 5**  
**FIT DEFECTS IN CAR COMPANY SERVICE PARTS THAT ARE OBSERVED IN PARTS APPLYING FOR CAPA CERTIFICATION**

When a CAPA manufacturer develops a new part using car company service parts that have fit problems, it is probable that the competitive part will exhibit a similar problem. This is why the CAPA program mandates the Vehicle Test Fit.

If the part presented for certification does have a fit problem, the manufacturer must correct it prior to certification. While these parts technically match the car company parts, because they don't fit, they cannot become certified.

In reality, while the CAPA parts matched their car company service counterparts, at times they were not fitting the vehicles for which they were intended. The reason: significant inconsistencies in the car company service parts. Reverse engineering duplicates everything, including defects that may not appear until the part is mounted on a vehicle. A defect in a car company service part that was copied in a CAPA part is referred to as a "follow-through" defect. (See Chart 5.)

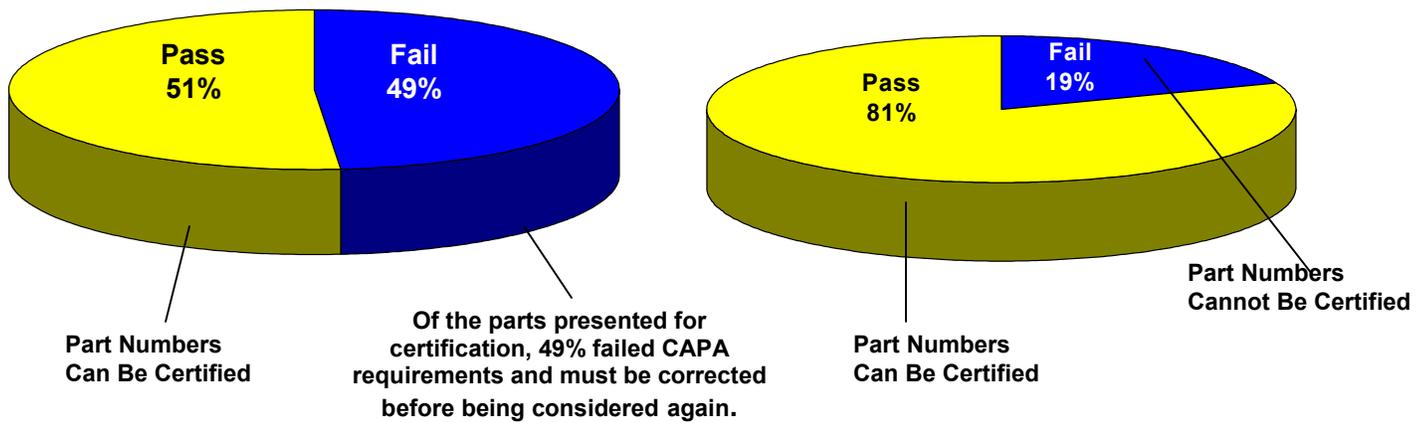
**CHART 6**  
**VEHICLE TEST FIT RESULTS**  
**PRELIMINARY AND SUBSEQUENT RETESTS**

Of the 49% of parts that failed on the first test, 62% were resubmitted. Of those, 81% passed. Overall 76% of CAPA parts presented became certified.

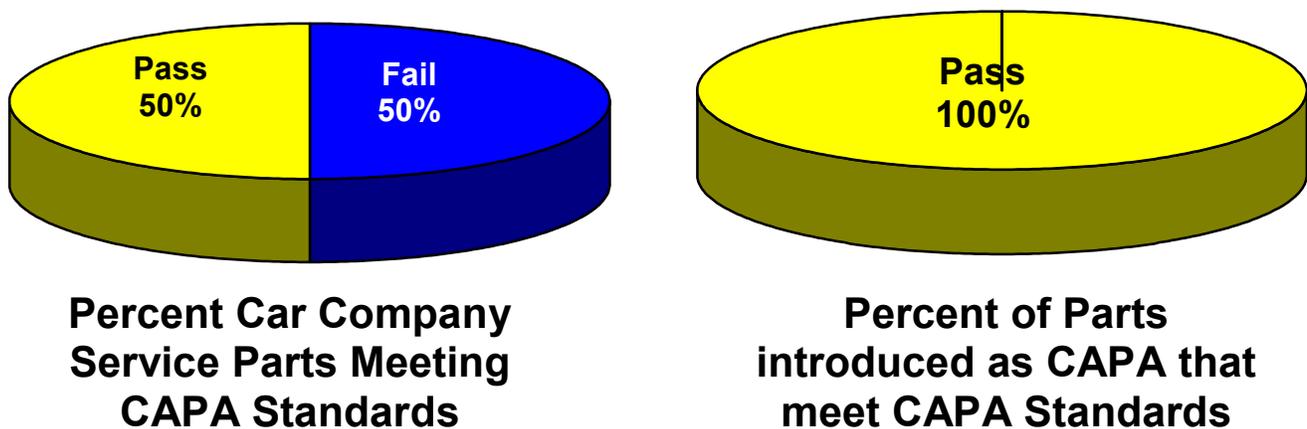
**CHART 7**  
**CAPA CERTIFIED PARTS ARE EQUIVALENT TO OR BETTER THAN THEIR**  
**CAR COMPANY SERVICE COUNTERPARTS.**

When compared to car company parts in the market, 100% of CAPA parts meet standards and only 50% of the car company parts meet the standards (Chart 7).

During the timeframe of this study, 49% of the new CAPA part numbers submitted for certification failed the vehicle test fit on their first attempt. Fifty percent of the car company service parts failed. The car company service parts remain available in the market with the noted defects. The independent parts failing will not be available on the market as CAPA certified until they have been fixed and fully comply with certification standards. For this reason, CAPA certified parts are equivalent to or better than the car company service counterparts.
