**Analysis of the Performance Auto Collision  
Comparison of a BMW Brand Part  
with a CAPA Certified Aftermarket Part  
Televised in a FOX 5 News (Atlanta)  
July 29, 2010 Report**

**October 19, 2010**

## CAPA Analysis of Performance Auto Collision's Comparative Demonstration of BMW Radiator Support Parts on FOX 5 News, July 29, 2010

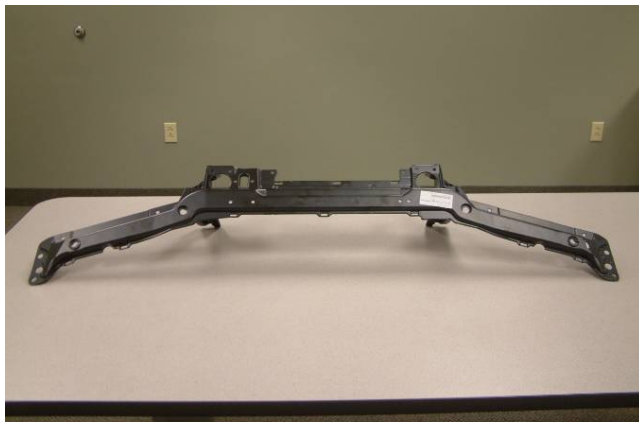
Figure 1. **BMW-made radiator support #51717114123 – Upper Tie Bar** for 1999-2006 BMW 3-Series Convertible (as received).

CAPA does NOT certify an aftermarket version of this part.

The upper tie bar is not attached to the lower tie bar, which is sold separately and has a separate part number.

This part cannot be used on the Sedan/Coupe/Wagon.

As the photographs below demonstrate, the BMW brand upper tie bar radiator support for the BMW 3-Series Convertible (Figure 1) is a very different part than the combined radiator support manufactured by BMW for the Sedan/Coupe/Wagon (Figure 2).

**BMW Convertible Radiator Support Part:** Not only is the Convertible's upper tie bar visually very different from the Sedan/Coupe/Wagon's riveted radiator support, it also contains a 'honeycomb' structure that is not present in the Sedan/Coupe/Wagon part. Currently, there are no CAPA Certified aftermarket parts available to replace the BMW Convertible upper tie bar.

**Radiator Support Material:** The upper tie bar used in the FOX 5 report that BMW manufactures for its Convertible is made of cast aluminum. The cast aluminum that BMW uses for this part (Figure 1 and 5) is thicker and much more robust than the wrought aluminum used by BMW to make the radiator support (Figure 2 and 4) for the Sedan/Coupe/Wagon. Wrought aluminum, in this particular geometric configuration, is relatively light and flexible.

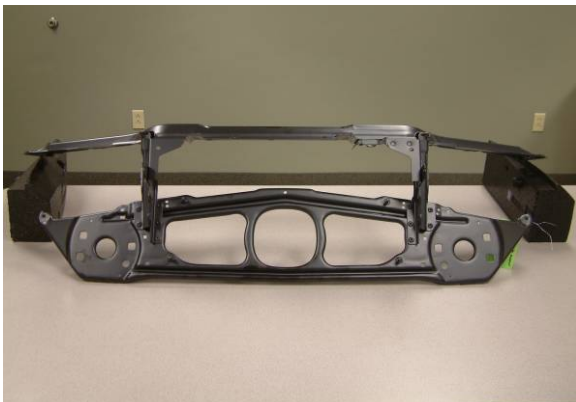
Figure 2. **BMW-made radiator support #51717111691** for 1999-2006 BMW 3-Series Sedan/Coupe/Wagon (as received).

CAPA certifies an aftermarket version of this part.

The upper and lower tie bars are riveted together by BMW during manufacturing.

**BMW Sedan/Coupe/Wagon Radiator Support Part:** As the photo in Figure 2 indicates, the BMW brand radiator support for the Sedan/Coupe/Wagon is very different from the Convertible part. It consists of an upper and lower tie bar riveted together at the factory and only sold as one piece. Because BMW does not want this part sold or used as two separate pieces, BMW has identified it by a single part number.

Not only is the CAPA Certified part made of wrought aluminum like the corresponding BMW brand part, but as the photographs in Figure 2 and 3 show, they are nearly identical in appearance and, most importantly, are both delivered as a single part, with the upper and lower tie bar portions riveted together.

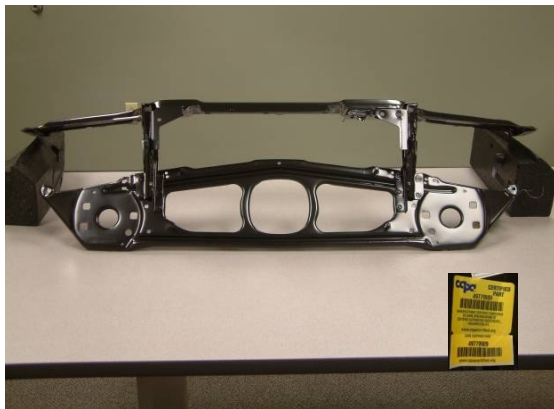
**Figure 3. CAPA Certified Gordon radiator support replacing BMW part #51717111691** for 1999-2006 BMW 3-Series Sedan/Coupe/Wagon (as received). This part cannot be used on the convertible.

The upper and lower tie bars are riveted together during manufacturing, the same as the BMW brand part.

CAPA Certification requires the aftermarket part to match the material of the car company brand counterpart. In the case of the CAPA Certified Gordon radiator support for the 1999-2006 BMW Sedan/Coupe/Wagon (Figure 3), the part is made of wrought aluminum like the BMW brand part.

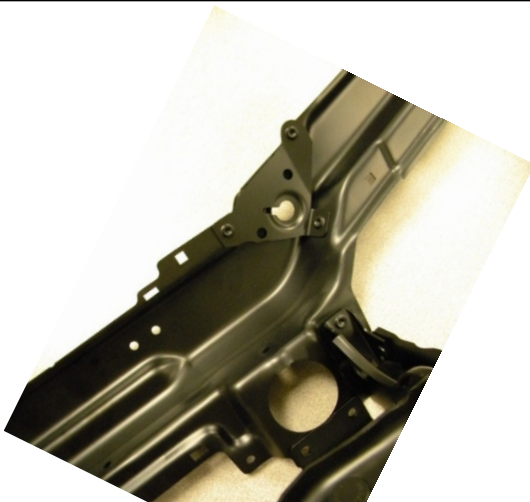
**Figure 4. Close-up of BMW brand upper tie bar portion of the radiator support for the Sedan/Coupe/Wagon.** In addition to being made of a different, softer material, BMW has designed this part very differently than its Convertible part.

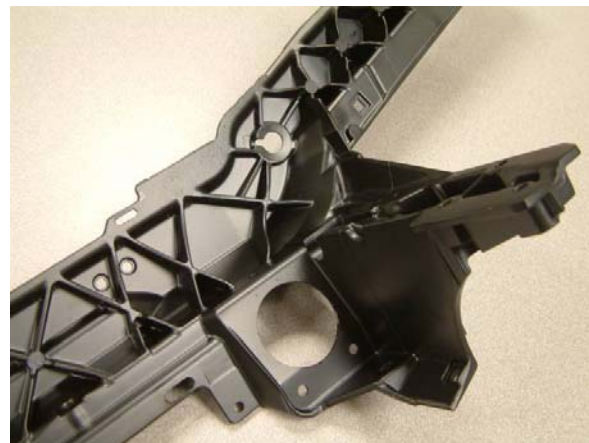
**Figure 5. Close-up of BMW brand upper tie bar for the Convertible.** Both the cast aluminum material and honeycomb structure stiffen the part and give it very different strength properties from the radiator support manufactured by BMW for its Sedan/Coupe/Wagon.
